Historic Resource Survey

Phase 1

**Historic Resource Survey
City of Carrollton**

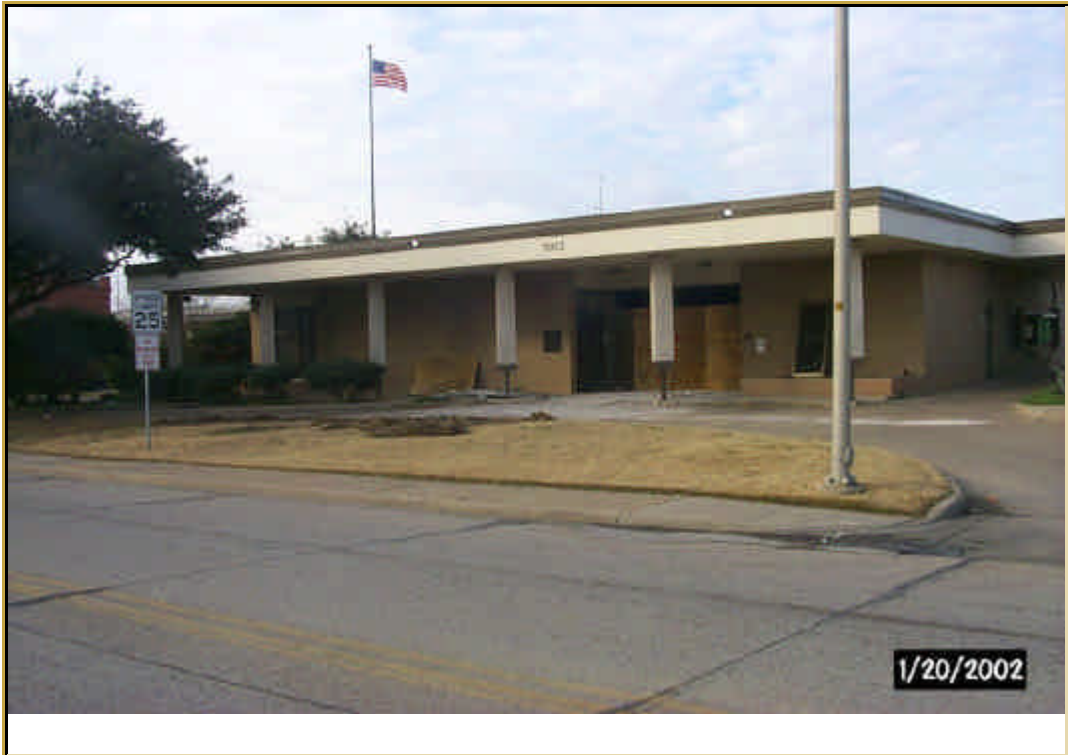
Lot:	9	Site Name:	Old City Hall	Current Owner:	City of Carrollton
Block:	A	Address:	1002	Street:	Broadway St S
Subdivision:	Orig Town Carrollton	Zip Code:	75006		
	- or -				
Abstract:		Survey Area:	Downtown		
Tract:		Description:	<p>One story rectangular plan brick commercial building with plate/aluminum sash on left front. Overhang with four pillars. Flat roof.</p>		
Survey:					
Preservation Priority:	low				
Physical Condition:	good				
Date Built:	1976				
Architect/Builder:		Alterations:			
Architectural Style:		Significance:			
Wall Material:	brick				
Roof Material:	tar & gravel				
Original Site:					
Date Moved:					
Original Use:					
Current Use:	City of Carrollton (Metrocr				
Date Surveyed:

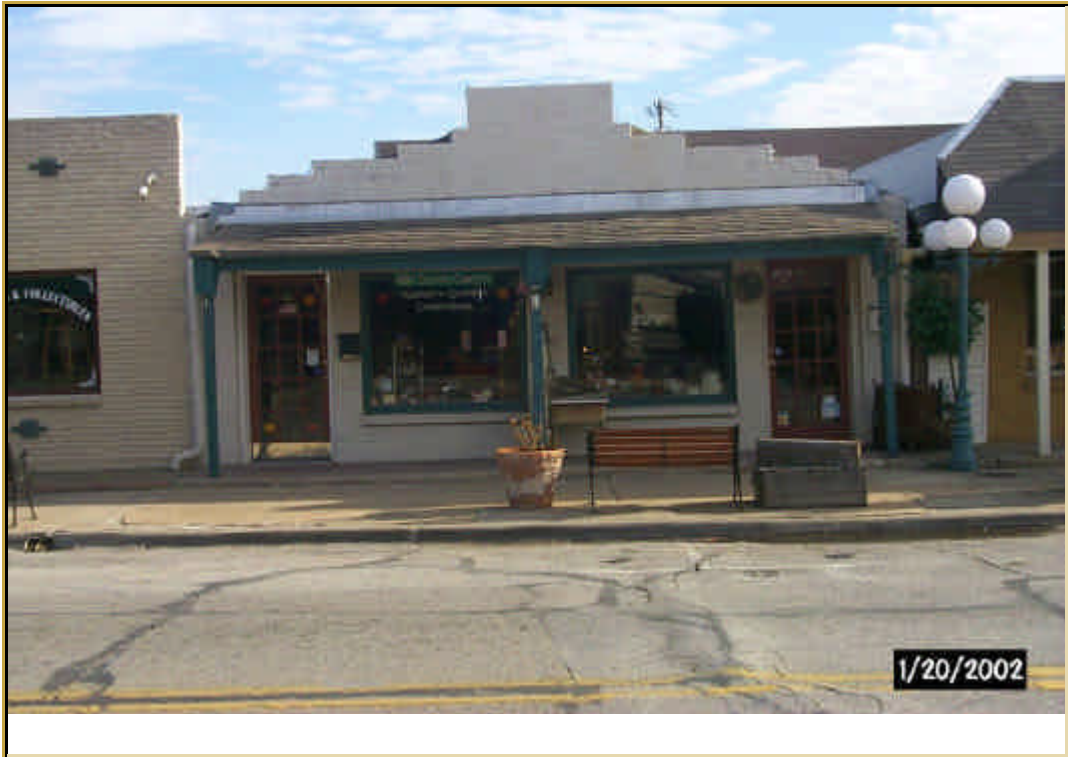
Lot:	12 (part)	Site Name:	ABH Creative Concepts	Current Owner:	Oldfield & Associates
Block:	AW	Address:	1015	Street:	Broadway St S
Subdivision:	Orig Town Carrollton			Zip Code:	75006
	- or -				
Abstract:		Survey Area:		Downtown	
Tract:		Description:			
Survey:		One story, brick commercial building with rectangular plan and two bays defined by piers. Stair-step parapet obscures slope roof.			
Preservation Priority:					
Physical Condition:	good				
Date Built:	1950				
Architect/Builder:					
Architectural Style:					
Wall Material:	brick				
Roof Material:	composition shingles				
Original Site:		Alterations:	Significance:		
Date Moved:					
Original Use:	commercial				
Current Use:	commercial				
Date Surveyed:

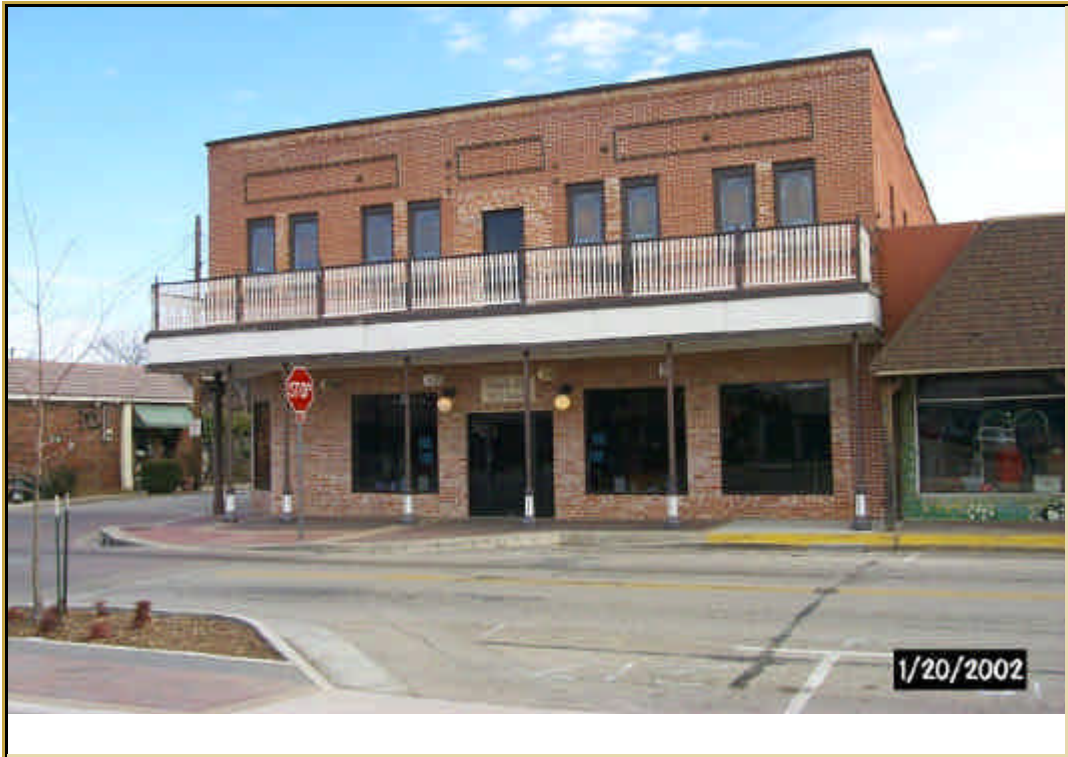
Lot:	9, 10	Site Name:	Oldfield Building	Current Owner:	David Oldfield
Block:	B	Address:	1101	Street:	Broadway St S
Subdivision:	Orig Town Carrollton	Zip Code:	75006		
	- or -				
Abstract:		Survey Area:	Downtown		
Tract:		Description:	<p>Two story rectangular plan brick commercial building with five bay commercial front and left side. Brick piers each side of bays. Raised brick accents on second floor. Wood front balcony.</p>		
Survey:					
Preservation Priority:	high				
Physical Condition:	good				
Date Built:	1924				
Architect/Builder:		Alterations:	Extensively remodeled/rehabilitated in late 1990's.		
Architectural Style:		Significance:			
Wall Material:	brick	Original Site:			
Roof Material:		Date Moved:			
		Original Use:	commercial		
		Current Use:	commercial		
Date Surveyed:

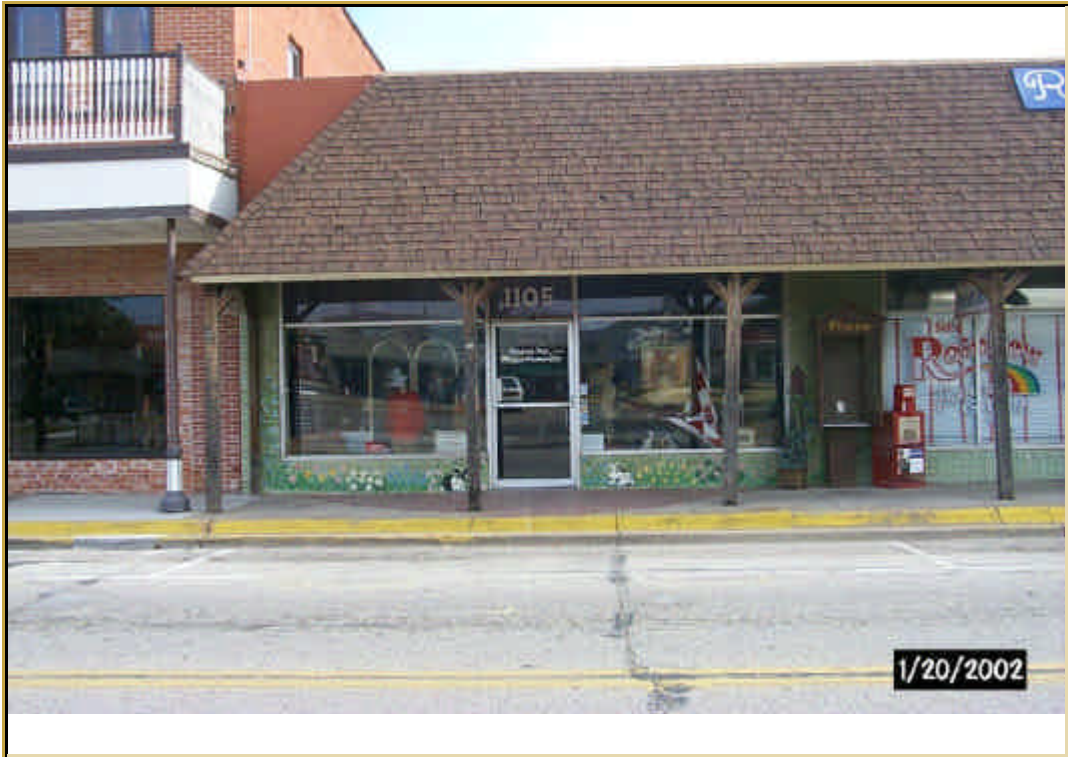
Lot:	11	Site Name:	Pleasures Past	Current Owner:	Jesse R. Woody
Block:	B	Address:	1105	Street:	Broadway St S
Subdivision:	Orig Town Carrollton	Zip Code:	75006		
	- or -			Survey Area:	Downtown
Abstract:		Description:			
Tract:		<p>One story rectangular plan brick commercial building with two bay commercial front. Display front in each bay has plate glass/aluminum sash. Mansard composition overhang. Flat roof behind parapet. Green tile on front.</p>			
Survey:					
Preservation Priority:	high				
Physical Condition:	good				
Date Built:	1924				
Architect/Builder:					
Architectural Style:					
Wall Material:	brick				
Roof Material:	composition				
Alterations:					
Original Site:					
Date Moved:					
Original Use:	commercial				
Current Use:	commercial				
Date Surveyed:

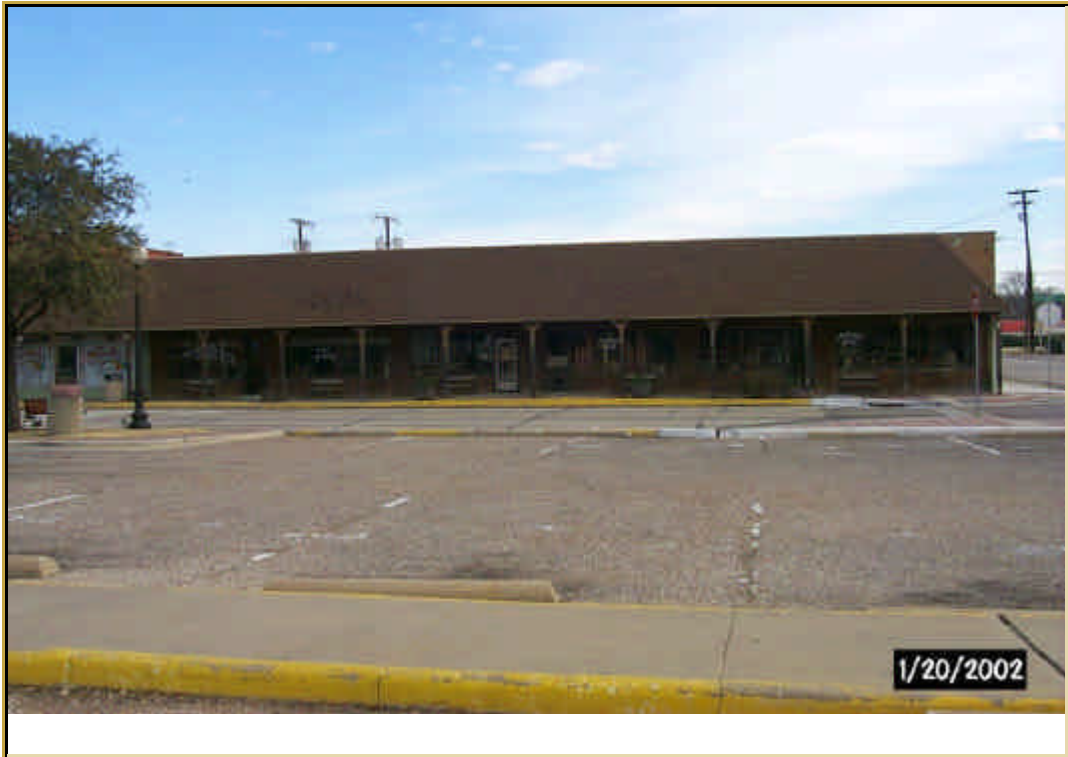
Lot:	12	Site Name:		Current Owner:	
Block:	2		Rainbow Fountain		Jesse R. Woody
Subdivision:	Orig Town Carrollton	Address:		Street:	
	- or -		1107	Broadway St S	75006
Abstract:				Survey Area:	Downtown
Tract:		Description:			
Survey:		One story brick commercial building with rectangular plan and two bay commercial front. Flat roof behind composition parapet. Green tile on front. Display front in each bay has plate glass/aluminum sash.			
Preservation Priority:					
Physical Condition:	good				
Date Built:	1924				
Architect/Builder:					
Architectural Style:					
Wall Material:	brick				
Roof Material:	composition				
Original Site:		Alterations:		Significance:	
Date Moved:					
Original Use:	commercial				
Current Use:	commercial				
Date Surveyed:

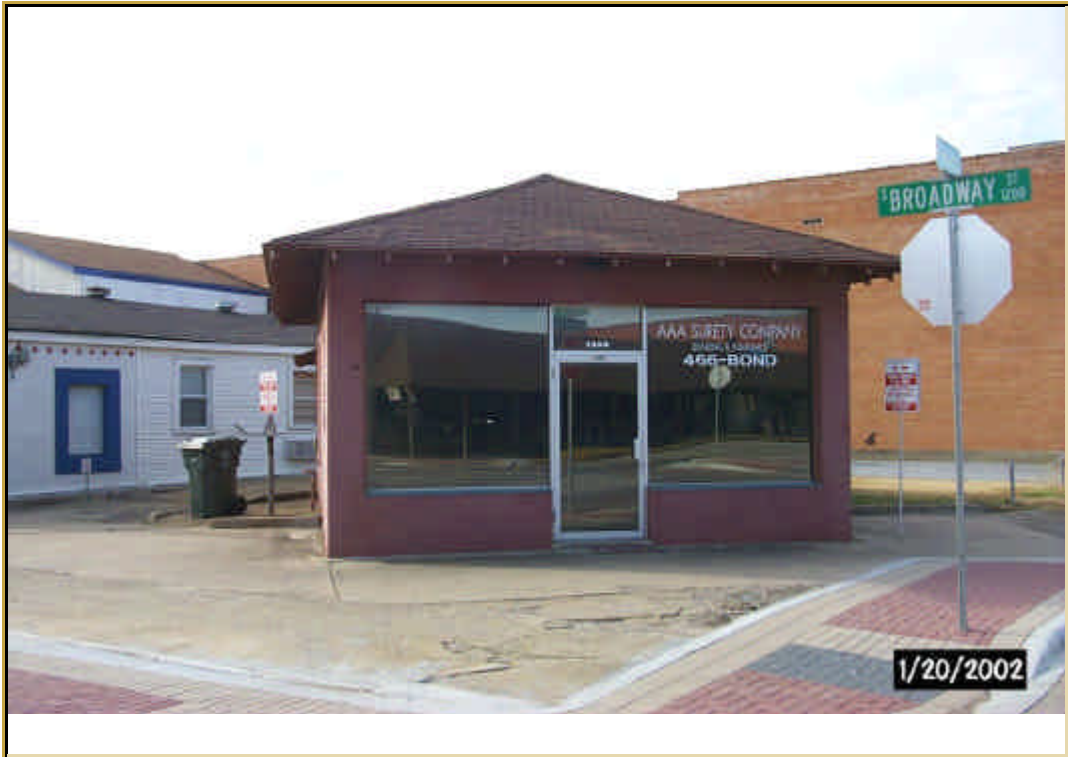
Lot:	Part 1 & 3	Site Name:	AAA Surety Company	Current Owner:	Noel Ray Russell
Block:	F	Address:	1200	Street:	Broadway St S
Subdivision:	Orig Town Carrollton	Zip Code:	75006		
	- or -				
Abstract:				Survey Area:	Downtown
Tract:		Description:			
Survey:		One story rectangular plan brick commercial building with two bay commercial front. Sloped composition roof.			
Preservation Priority:	moderate				
Physical Condition:	good				
Date Built:	1940				
Architect/Builder:					
Architectural Style:					
Wall Material:	brick				
Roof Material:	composition				
Original Site:		Alterations:	Significance:		
Date Moved:					
Original Use:	commercial				
Current Use:	commercial				
Date Surveyed:

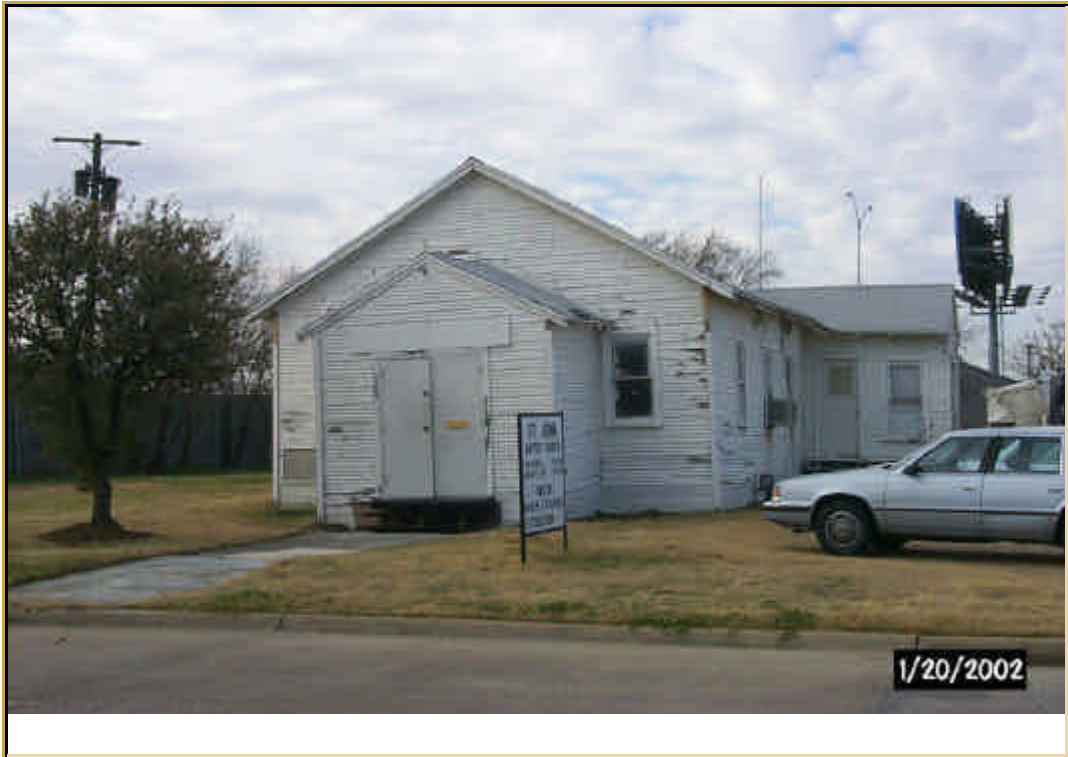
Lot:	<input type="text"/>	Site Name:	<input type="text"/>	Current Owner:	<input type="text"/>
Block:	<input type="text"/>			Servando Nunez	
Subdivision:	<input type="text"/>	Address:	Street:	Zip Code:	
	- or -	1405	Broadway St S	75006	
Abstract:	799 p 120			Survey Area:	Downtown
Tract:	14	Description:			
Survey:	William Lerner	One story "ell"r plan wood house. Side porch. Fixed multiple light wood sash windows. Sloped composition roof.			
Preservation Priority:	high				
Physical Condition:	fair				
Date Built:	1910				
Architect/Builder:	<input type="text"/>				
Architectural Style:	<input type="text"/>				
Wall Material:	wood				
Roof Material:	composition				
Original Site:	<input type="text"/>	Alterations:	Significance:		
Date Moved:	<input type="text"/>				
Original Use:	residence				
Current Use:	residence				
Date Surveyed:	<input type="text"/>

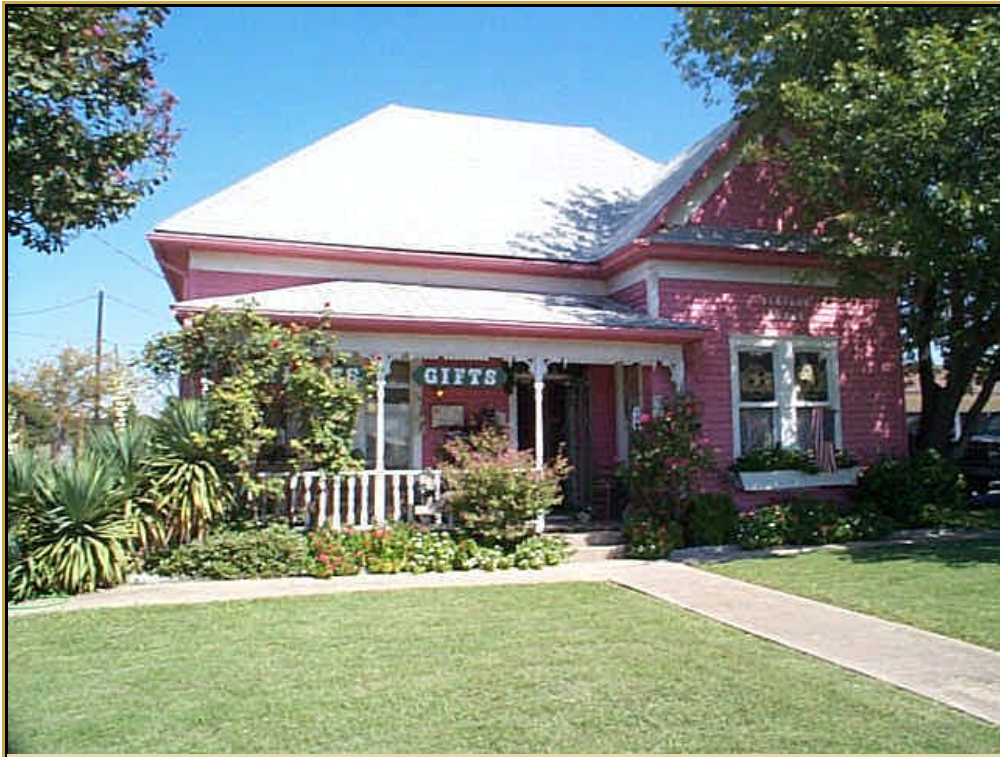
Lot:	2 - 7	Site Name:	Boatright House	Current Owner:	Carolyn Walvoord
Block:	12	Address:	1101	Street:	Belt Line Rd
Subdivision:	A.W. Perry			Zip Code:	75006

- or -				
Abstract:				Survey Area:	Carrollton Heights
Tract:		Description:			
Survey:		One-story frame house with assymetrical plan. Hip-roofed, with a gable "ell" extending in front. Hip-roofed porch in front. Gable end has shingle detail and "dent" roof connecting eaves. Structure also listed in 1982 Dallas County Survey.			
Preservation Priority:	High				
Physical Condition:	Good				
Date Built:	1905 (?)				
Architect/Builder:					
Architectural Style:					
Wall Material:	wood siding/clapboard				
Roof Material:	composition shingles				
Original Site:		Alterations:	Significance:		
Date Moved:		"Victorian" decorative elements (i.e. "bric-a-brac") added (?) to porch. Additions to building in rear.			
Original Use:	residence				
Current Use:	retail store				
Date Surveyed:

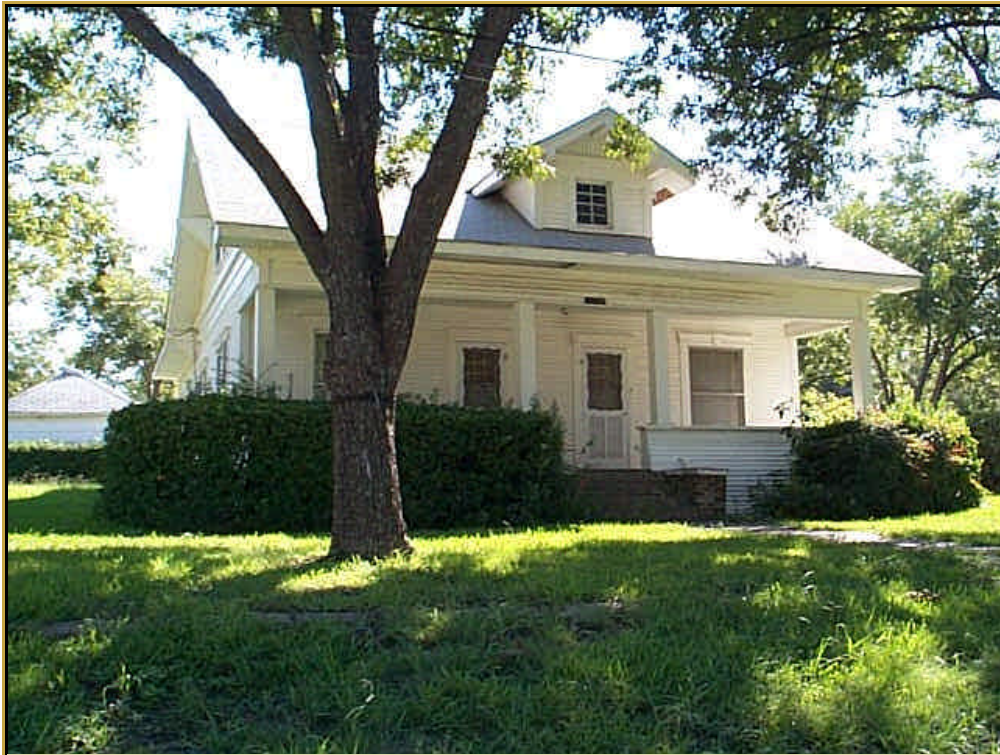
Lot:	1 (part)	Site Name:	J H Rhoton House	Current Owner:	Gordon Sorber
Block:		Address:	1501	Street:	Belt Line Rd E
Subdivision:	J H Maltpress 1	Zip Code:	75006		
	- or -				
Abstract:		Survey Area:	Carrollton Heights		
Tract:		Description:	<p>One-story "ell" plan frame house with porch in SW "ell" and projecting rectangular window bay on W elevation. Hip roof. Shed-roofed porch, now screened, has wooded box columns. 1/1 wood-sash windows. Splayed base around home.</p>		
Survey:					
Preservation Priority:	high				
Physical Condition:	good				
Date Built:	1905				
Architect/Builder:					
Architectural Style:	craftsman				
Wall Material:	asbestos siding over woo				
Roof Material:	composition shingle				
Original Site:		Alterations:	Asbestos siding added. Porch screened-in.		
Date Moved:		Significance:			
Original Use:	residence				
Current Use:	residence				
Date Surveyed:

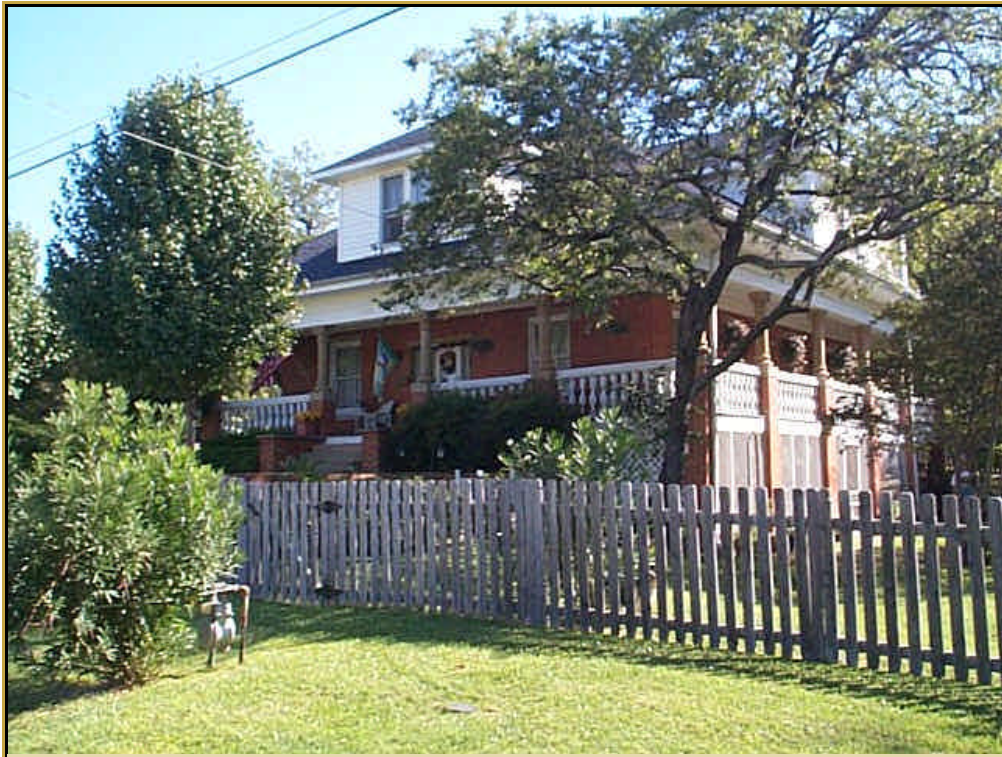
Lot:	4, 5 & 6	Site Name:	Belle Allen Home	Current Owner:	Bruce McDonald
Block:	3	Address:	1208	Street:	Clint St
Subdivision:	W F Jackson			Zip Code:	75006

- or -				
Abstract:				Survey Area:	Carrollton Heights
Tract:		Description:			
Survey:		<p>Rectangular plan, 1 1/2 story with partially raised basement. Inset porch on W and S elevations; Hip roof has dormers on each elevation; windows are 1/1 wood sash; central door on W elevation has sidelights; porch supports are carved stone columns on brick piers; piers lengthened on S elevation where basement is exposed. Also listed in 1982 Dallas County Survey.</p>			
Preservation Priority:	high				
Physical Condition:	good				
Date Built:	1910				
Architect/Builder:					
Architectural Style:	Prairie Four-Square				
Wall Material:	brick				
Roof Material:	composition shingles				
Original Site:		Alterations:	Basement porch screened.		
Date Moved:			Significance:		
Original Use:	residence		Detailing. Only residential structure to be of Carrollton brick. Home of civic leader Belle Allen.		
Current Use:	residence

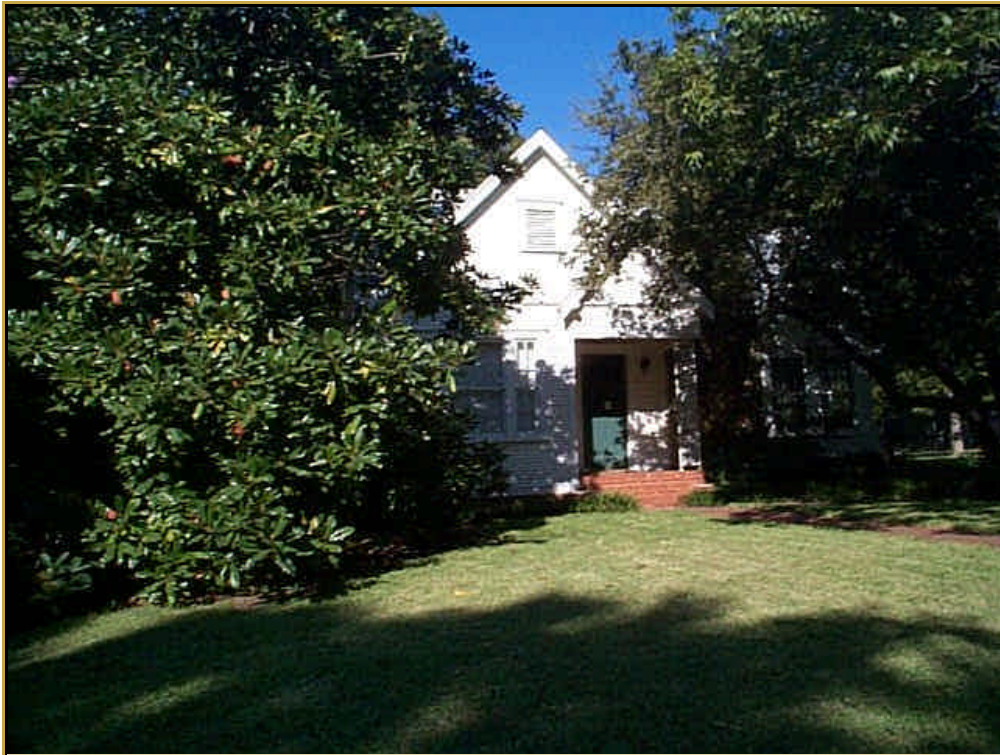
Lot:	6	Site Name:		Current Owner:	
Block:	1		Chester Good House		Mary Skopin
Subdivision:	J H Maltpress 2	Address:	Street:	Zip Code:	
	- or -	1011	Maryland St N	75006	
Abstract:				Survey Area:	Carrollton Heights
Tract:		Description:			
Survey:		<p>One and one-half story, rectangular plan house with inset porch under front gable. Built by Will Nix, who also built 1011, 1012 and 1101 Maryland. Original owners were Chester & Mary Good. Chester was the school electrician, and Mary was the school librarian. Chester's sister, Ora Good, lived across street, and his niece, Jo Anne, still owns 1012 Maryland. Second owners were Ron & Elaine Marchant. Ron is brother of Kenny Marchant, a state representative.</p>			
Preservation Priority:	low				
Physical Condition:	good				
Date Built:	1926				
Architect/Builder:					
Architectural Style:	craftsman				
Wall Material:	wood siding				
Roof Material:	composition shingles

Original Site:		Alterations:	Significance:		
Date Moved:		Original porch support replaced with "wrought iron" decorative post. Side porch enclosed in 1940's or 50's. Additional bath and walk-in closet added circal 1984.			
Original Use:	residence				
Current Use:	residence				
Date Surveyed:

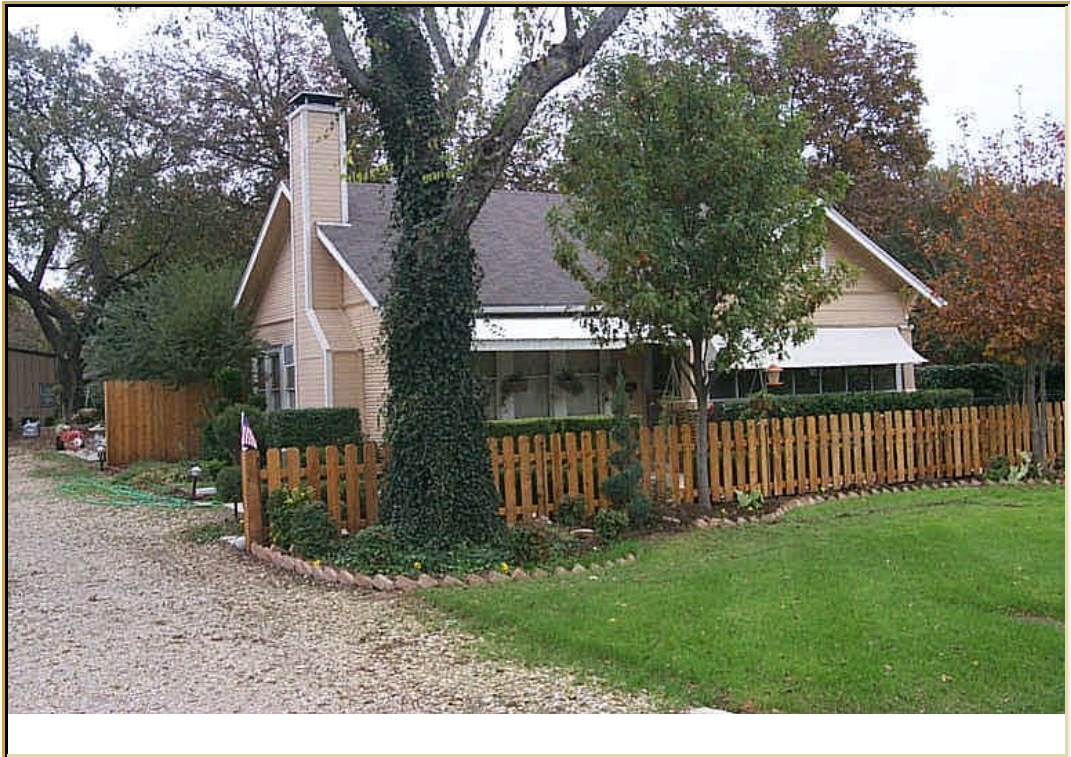
Lot:	7 & 8	Site Name:		Current Owner:	
Block:	1			Alton Davis	
Subdivision:	J H Maltpress 2	Address:	Street:	Zip Code:	
	- or -	1015	Maryland St N	75006	
Abstract:				Survey Area:	Carrollton Heights
Tract:		Description:			
Survey:		<p>Rectangular plan house with front facing gables. Secondary gable is stepped under main, porch is under projecting tertiary gable. Stuccoed chimney is in secondary gable.</p>			
Preservation Priority:	low				
Physical Condition:	good				
Date Built:	1915				
Architect/Builder:					
Architectural Style:	Craftsman				
Wall Material:	wood siding				
Roof Material:	composition shingles				
Original Site:		Alterations:	Significance:		
Date Moved:		Removal of square box pillars that supported porch roof. Replaced by metal supports.			
Original Use:	residence				
Current Use:	residence				
Date Surveyed:	12/18/01

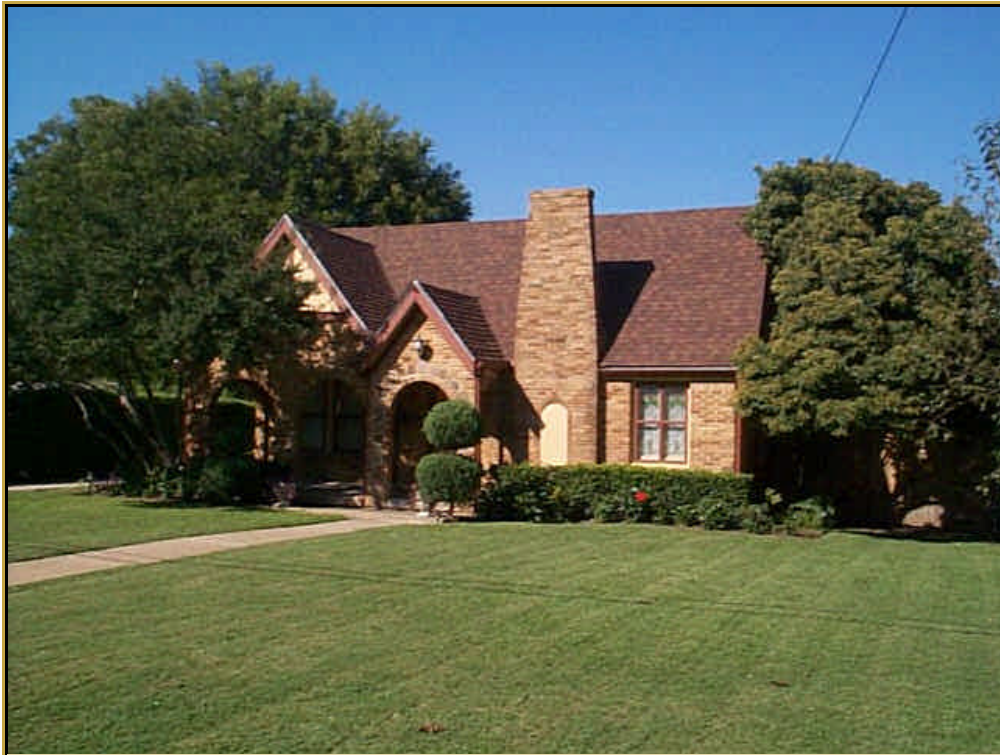
Lot:	3 & part 2	Site Name:		Current Owner:	
Block:	7			David Terrell	
Subdivision:	J H Maltpress 2	Address:	Street:	Zip Code:	
	- or -	1104	Maryland St N	75006	
Abstract:				Survey Area:	Carrollton Heights
Tract:		Description:			
Survey:		Rectangular plan, side gabled house. Projecting front gable section. Inset porch. Triangular brackets under gables. Exposed beams.			
Preservation Priority:	low				
Physical Condition:	good				
Date Built:	1924				
Architect/Builder:					
Architectural Style:	Craftsman				
Wall Material:	wood siding				
Roof Material:	composition shingles				
Original Site:		Alterations:	Significance:		
Date Moved:					
Original Use:	residence				
Current Use:	residence				
Date Surveyed:

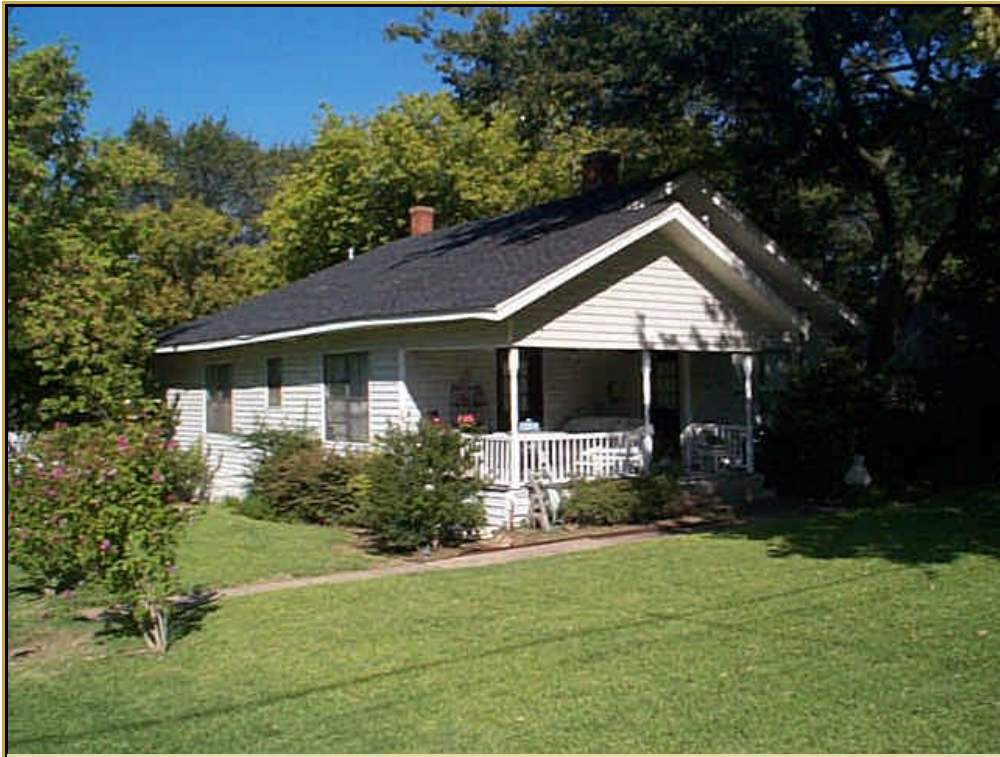
Lot:	4	Site Name:		Current Owner:	
Block:	7			Joseph Kelly	
Subdivision:	J H Maltpress 2	Address:	Street:	Zip Code:	
	- or -	1106	Maryland St N	75006	
Abstract:				Survey Area:	Carrollton Heights
Tract:		Description:			
Survey:		One and one-half story colonial revival house with symmetrical facade. Cross-gabled with front facing gabled section on either side of entrance. Inset porch surmounted by decorative ballustrade supported by two square columns.			
Preservation Priority:					
Physical Condition:					
Date Built:	1932				
Architect/Builder:					
Architectural Style:	Colonial Revival				
Wall Material:	vinyl siding (over wood)				
Roof Material:	composition shingles				
Original Site:		Alterations:	Significance:		
Date Moved:		Vinyl siding added over ship-lap wood siding. Addition to rear of house. Rear porch glassed in. Decorative ballustrade added.			
Original Use:	residence				
Current Use:	residence

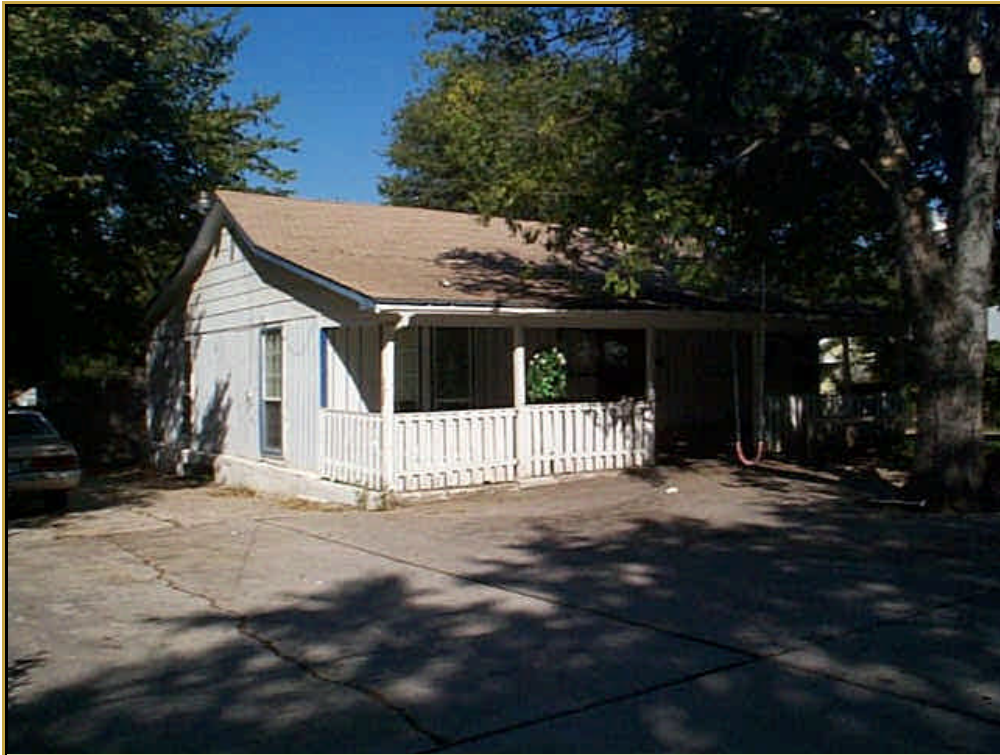
Lot:	12	Site Name:		Current Owner:	
Block:	3			Brenda Humbert	
Subdivision:	J H Maltpress 2	Address:	Street:	Zip Code:	
	- or -	1201	Maryland St N	75006	
Abstract:				Survey Area:	Carrollton Heights
Tract:		Description:			
Survey:		Rectangular plan, front gabled house with porch.			
Preservation Priority:	low				
Physical Condition:	good				
Date Built:	1915				
Architect/Builder:					
Architectural Style:	Craftsman				
Wall Material:	wood siding				
Roof Material:	composition shingled				
Original Site:		Alterations:	Significance:		
Date Moved:		Vinyl siding added over wood siding. Original box pillars on porch replaced with turned wood postes and Queen Anne railing. Removal of decorative triangular brackets and covering of rafter ends.			
Original Use:	residence				
Current Use:	residence				
Date Surveyed:	12/18/01

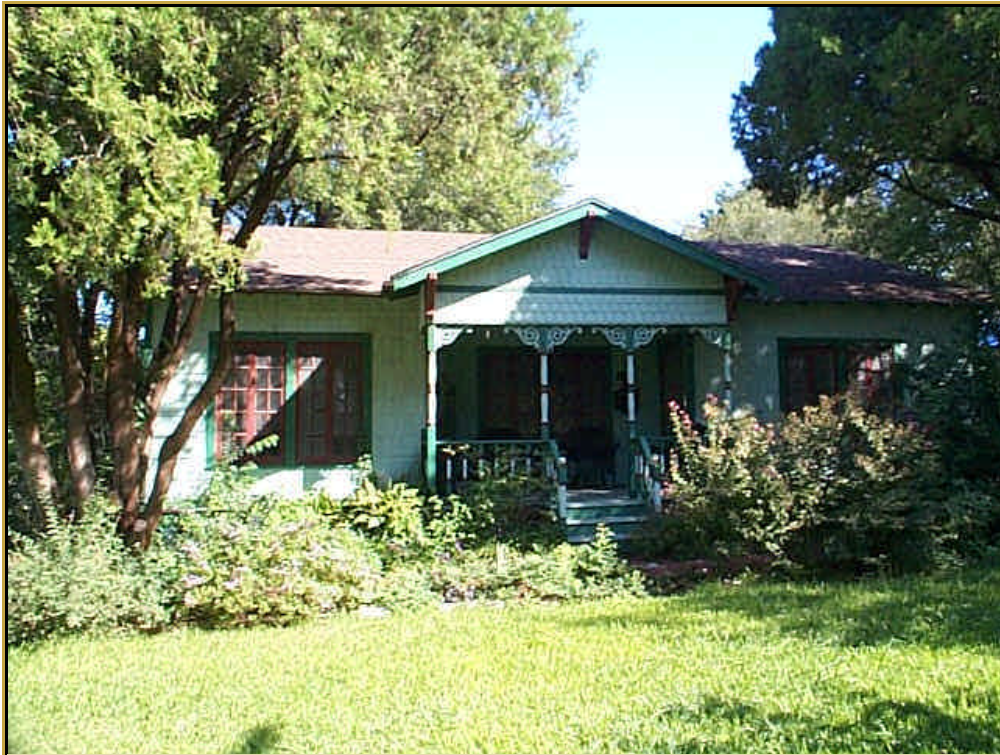
Lot:	15 & 16	Site Name:	J.P. Martin House	Current Owner:	Harold Simon
Block:	4	Address:	1401	Street:	Rosemon Ave
Subdivision:	Carrollton Heights			Zip Code:	75006

- or -				
Abstract:				Survey Area:	Carrollton Heights
Tract:		Description:			
Survey:		Symmetrical exterior and centered front porch. Single-story pier and beam. Combination of three-over-one sash windows and multi-light casement windows (in front). Matched front doors. "Cinder-block" construction "ell" addition in rear used as den/family room. Original detached garage still in place.			
Preservation Priority:	moderate				
Physical Condition:	good				
Date Built:	1928 (1932?)				
Architect/Builder:					
Architectural Style:					
Wall Material:					
Roof Material:					
Original Site:		Alterations:	Significance:		
Date Moved:		Reorientation of front porch entry in 1990. Victorian & Queen Anne details added 1995. "Cinder-block" garage added to house circa 1950, now used as family room.	Martin operated Carrollton newspaper from mid-1920's to early 1940's. Mrs. Martin taught piano here.		
Original Use:	residence

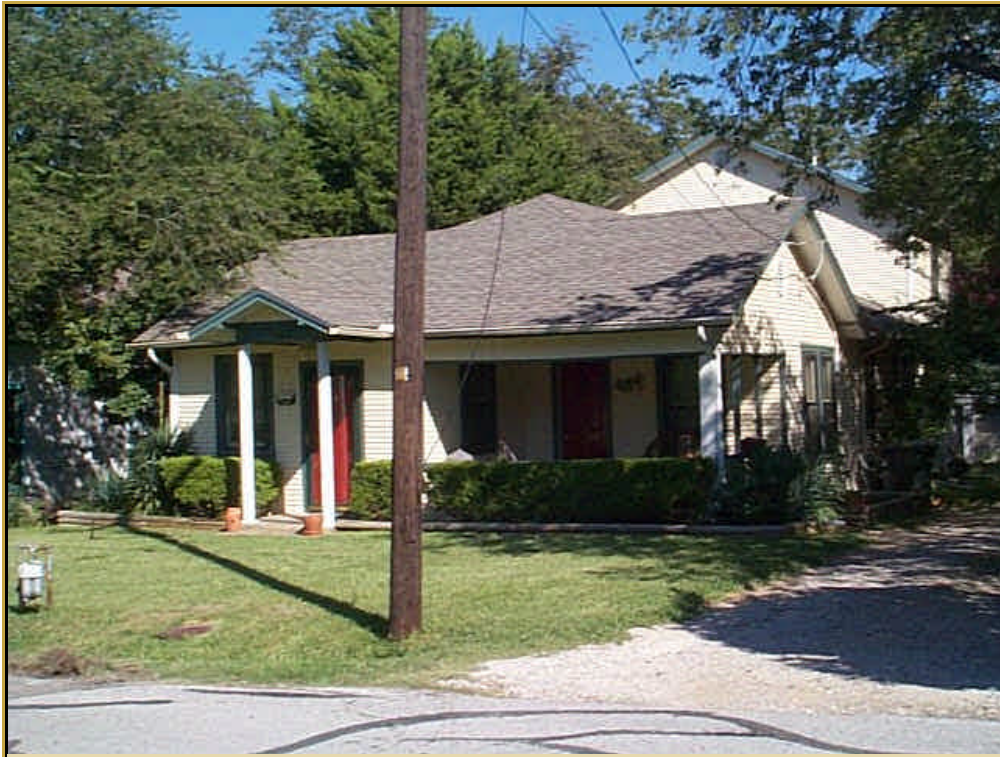
Lot:	13	Site Name:		Current Owner:	
Block:	4	Kennedy House		Alvaro Garcia	
Subdivision:	Carrollton Heights	Address:	Street:	Zip Code:	
	- or -	1407	Rosemon Ave	75006	
Abstract:				Survey Area:	Carrollton Heights
Tract:		Description:			
Survey:		One-story, asymmetrical-plan wood frame house with shed porch in Southwest "ell" sheltering entry. Gables extend from hip roof. Wood sash windows. Slender round wooden "doric" columns support porch. Also listed in 1982 Dallas County Survey.			
Preservation Priority:					
Physical Condition:	fair				
Date Built:	1910 (?)				
Architect/Builder:					
Architectural Style:	Folk Victorian				
Wall Material:	wood siding				
Roof Material:	composition shingles				
Original Site:		Alterations:	Significance:		
Date Moved:		Dining room, two bedrooms, closet, laundry room and storage room were added.			
Original Use:	residence				
Current Use:	residence				
Date Surveyed:

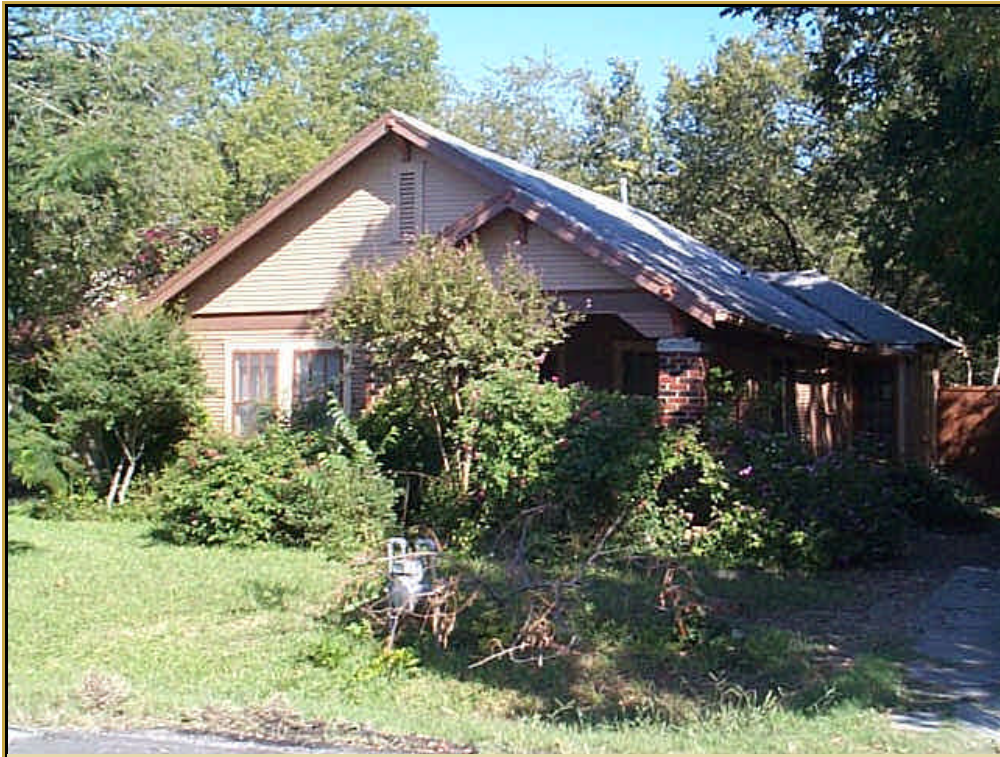
Lot:	12	Site Name:		Current Owner:	
Block:	4		Patterson House		Martin Gingles
Subdivision:	Carrollton Heights	Address:		Street:	Zip Code:
	- or -	1409		Rosemon Ave	75006
Abstract:				Survey Area:	Carrollton Heights
Tract:		Description:			
Survey:		Side gabled, rectangular plan house with small projecting front entrance gable over porch. Inset side porch. Triangular brackets under gables. Original owner (and builder?) G.W. Patterson, was a truck driver who also sold eggs to the neighborhood from a stand in the back yard.			
Preservation Priority:					
Physical Condition:	good				
Date Built:	1918				
Architect/Builder:					
Architectural Style:	Craftsman				
Wall Material:	wood siding				
Roof Material:	composition shingles				
Original Site:		Alterations:		Significance:	
Date Moved:		Significant additions to rear.		Original owner (& builder?) G.W. Patterson was truck driver who also sold eggs to neighborhood from stand in back yard.

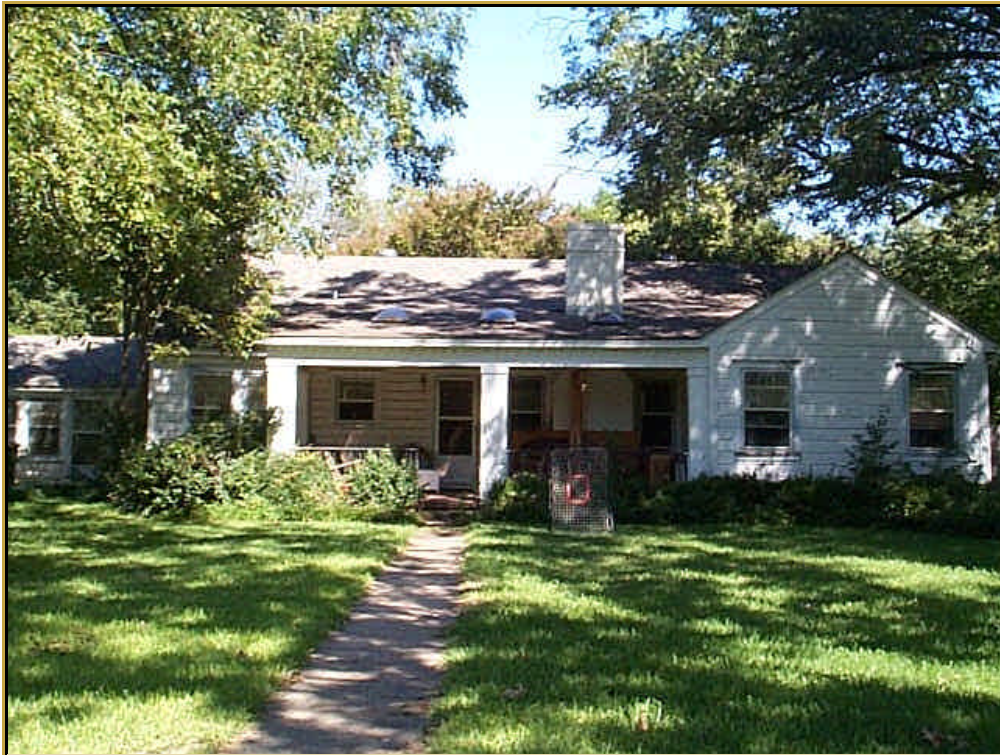
Lot:	<input type="text"/>	Site Name:	<input type="text"/>	Current Owner:	<input type="text"/>
Block:	<input type="text"/>		<input type="text"/>	Leroy Stinson	
Subdivision:	<input type="text"/>	Address:	Street:	Zip Code:

- or -	1617	Rosemon Ave	75006	
Abstract:	798 p 505			Survey Area:	Carrollton Heights
Tract:	<input type="text"/>	Description:			
Survey:	Joshua B Lee	Side gabled house with projecting front gabled section. "EII" plan. Shed style front porch supported by two square brick pillars. Chimney projects through porch roof. Recessed, attached garage.			
Preservation Priority:	moderate				
Physical Condition:	good				
Date Built:	1935				
Architect/Builder:	<input type="text"/>				
Architectural Style:	American Traditional	Alterations:			
Wall Material:	wood siding	Significance:			
Roof Material:	composition shingles	<input type="text"/>			
Original Site:	<input type="text"/>				
Date Moved:	<input type="text"/>				
Original Use:	residence				
Current Use:	residence	<input type="text"/>			
Date Surveyed:	<input type="text"/>

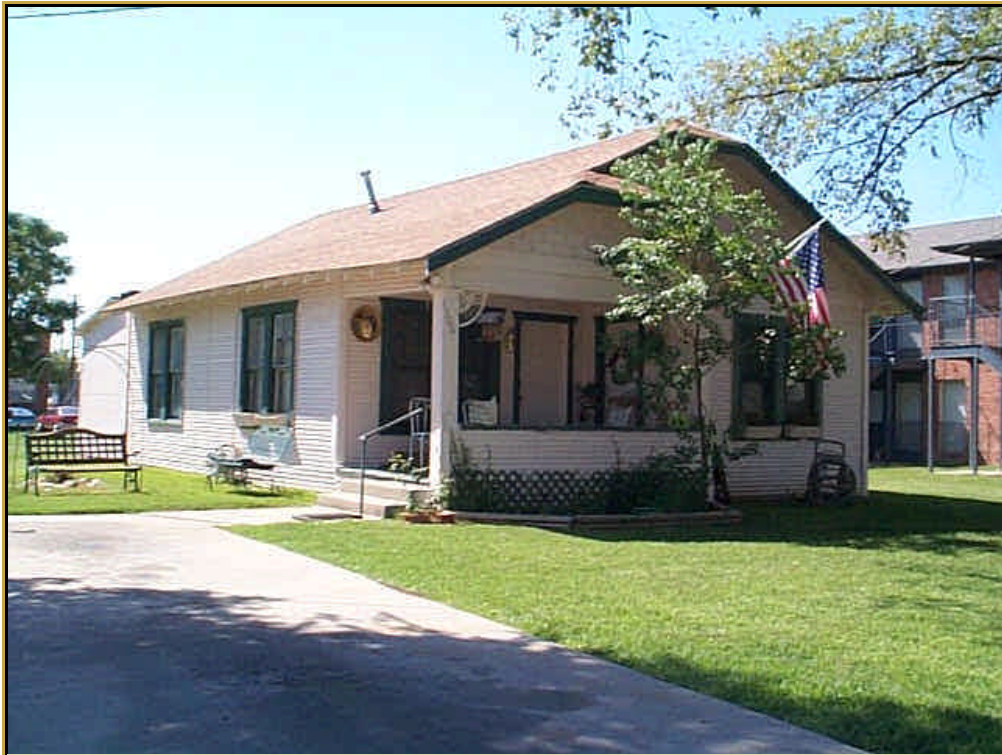
Lot:		Site Name:		Current Owner:	
Block:				Jimmy Lee Young	
Subdivision:		Address:	Street:	Zip Code:	
	- or -	1306	Walnut St	75006	
Abstract:	798 p 130			Survey Area:	Carrollton Heights
Tract:	6	Description:			
Survey:	Joshua B Lee	<p>Rectangular plan, front gabled house. Projecting porch gable inset from roof line. Gables are clipped. Porches supported by square box posts on either end. Decorative triangular brackets under gables with exposed rafter ends.</p>			
Preservation Priority:	low				
Physical Condition:	good				
Date Built:	1925				
Architect/Builder:					
Architectural Style:	Craftsman				
Wall Material:	wood siding				
Roof Material:	composition shingles				
Original Site:		Alterations:	Significance:		
Date Moved:					
Original Use:	residence				
Current Use:	residence				
Date Surveyed:	12/18/01

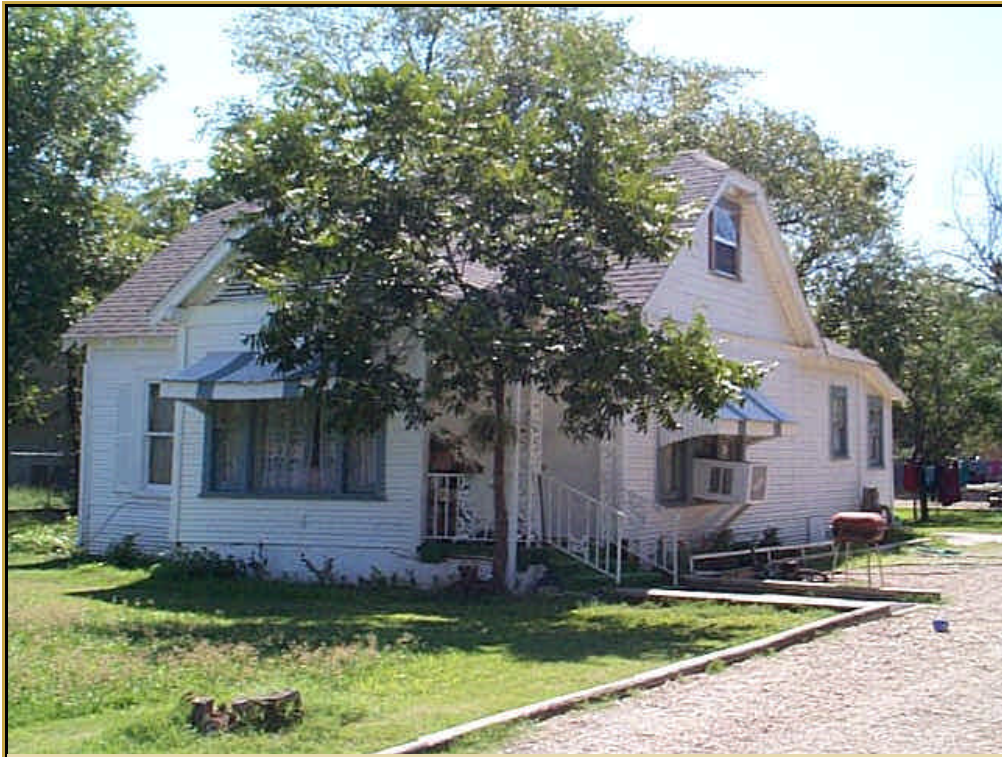
Lot:	6 & 7 and part 4	Site Name:		Current Owner:	
Block:	7			Fst Baptist Church (Kenneth Bush Trust)	
Subdivision:	Carrollton Heights	Address:	1314	Street:	Walnut St
	- or -			Zip Code:	75006
Abstract:				Survey Area:	Carrollton Heights
Tract:		Description:			
Survey:		Rectangular plan, side gabled house with projecting front gable section and side entry. Gables are clipped.			
Preservation Priority:	low				
Physical Condition:	fair				
Date Built:	1929				
Architect/Builder:					
Architectural Style:	Craftsman				
Wall Material:	wood siding				
Roof Material:	composition shingles				
Original Site:		Alterations:	Significance:		
Date Moved:		Porch roof supports replaced with metal decorative posts.			
Original Use:	residence				
Current Use:	residence				
Date Surveyed:

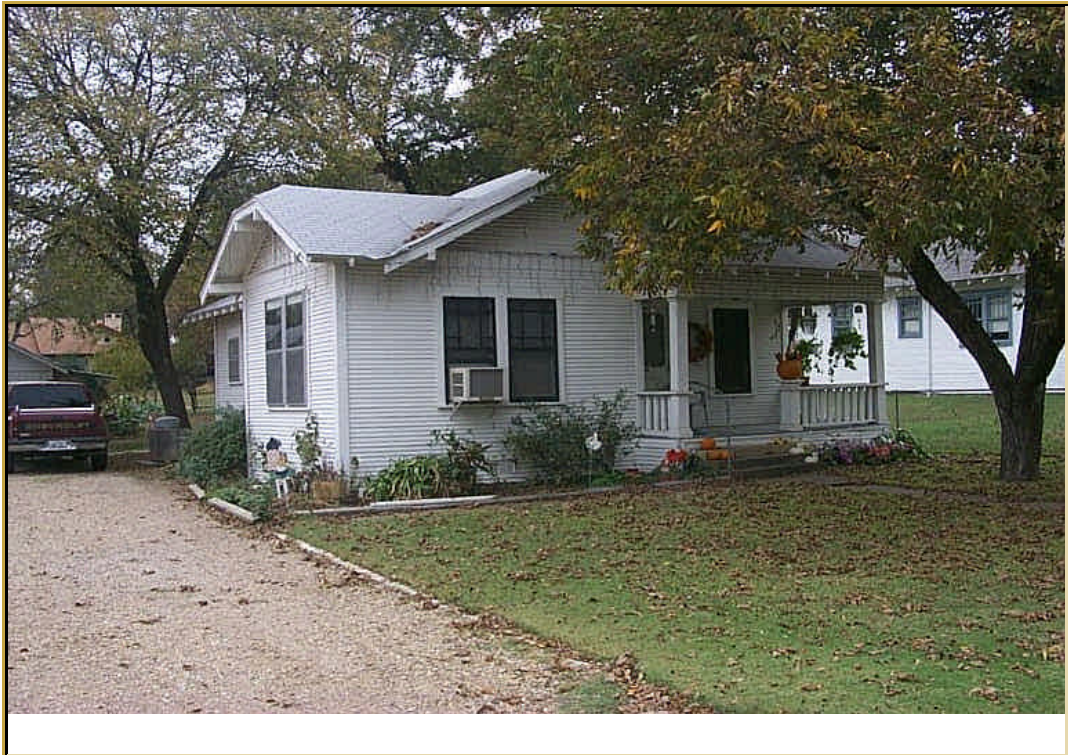
Lot:	10	Site Name:		Current Owner:	
Block:	6			Clyde Russell	
Subdivision:	Carrollton Heights	Address:	Street:	Zip Code:	
	- or -	1317	Walnut St	75006	
Abstract:				Survey Area:	Carrollton Heights
Tract:		Description:			
Survey:		Rectangular plan, front gabled house with inset porch and small projecting side gable. Gables are clipped. Porch supported by two square box columns. Craftsman railing. Decorative triangular brackets under gables with exposed rafters.			
Preservation Priority:	low				
Physical Condition:	fair				
Date Built:	1920 (?)				
Architect/Builder:					
Architectural Style:	Craftsman				
Wall Material:					
Roof Material:					
Original Site:		Alterations:	Significance:		
Date Moved:					
Original Use:	residence				
Current Use:	residence				
Date Surveyed:
