Historic Resource Survey

Phase 1

**Historic Resource Survey
City of Carrollton**

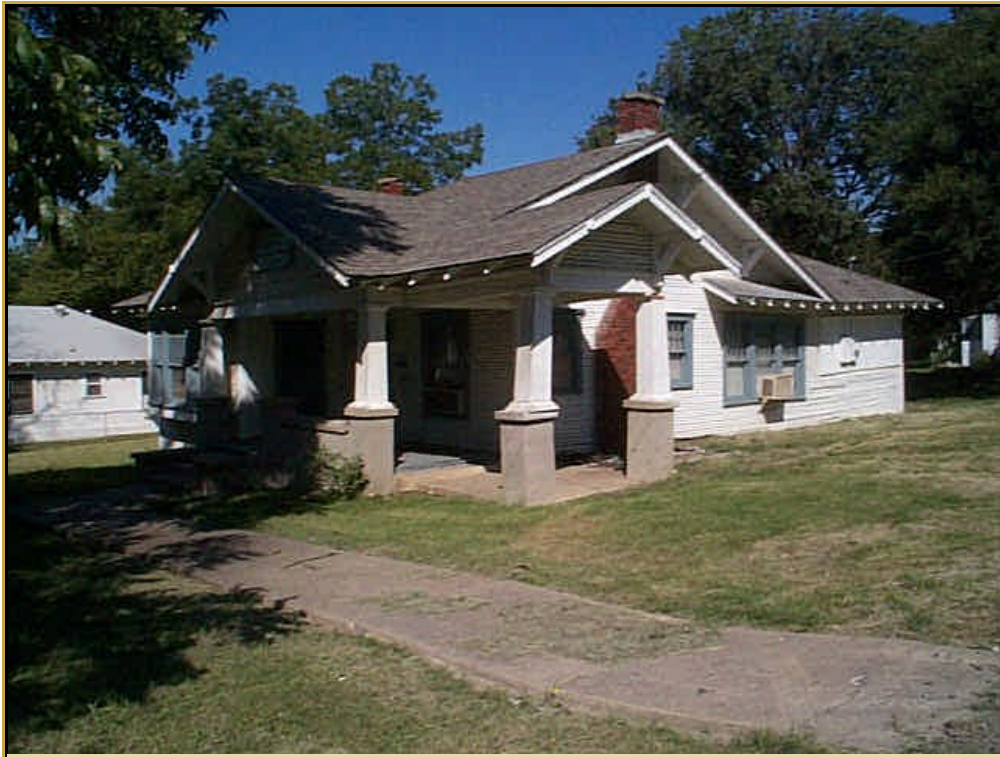
Lot:	11 & 12	Site Name:	Jake Gravley House	Current Owner:	First Baptist Church
Block:	6	Address:	1321	Street:	Walnut St
Subdivision:	Carrollton Heights	Zip Code:			
	- or -				
Abstract:		Survey Area:	Carrollton Heights		
Tract:		Description:	<p>Rectangular plan, cross gabled house. Projecting side gabled porte-cochere adjacent to inset front porch. Porch roof supported by tapered wooden box columns on cement piers. Triangular decorative brackets under gable and exposed rafter ends.</p>		
Survey:					
Preservation Priority:	high				
Physical Condition:	fair				
Date Built:	1930				
Architect/Builder:					
Architectural Style:	Craftsman				
Wall Material:	wood siding				
Roof Material:	composition shingles				
Alterations:	Rear porch enclosed.	Significance:			
Original Site:					
Date Moved:					
Original Use:	residence				
Current Use:	office/storage				
Date Surveyed:

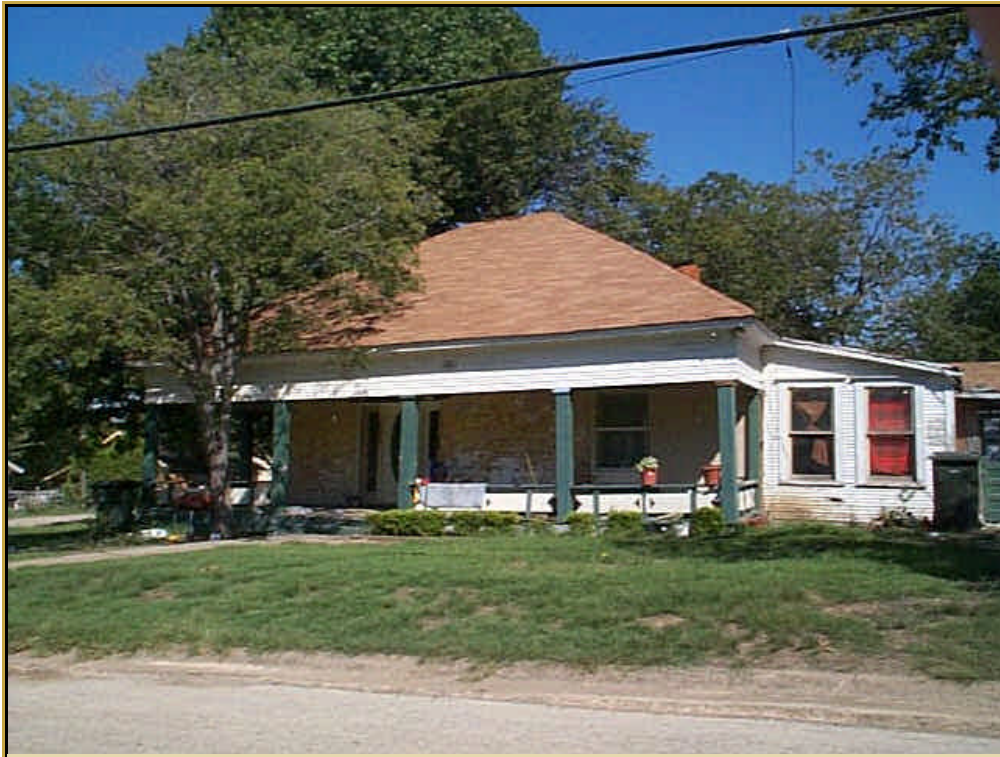
Lot:	1	Site Name:			Current Owner:		
Block:	2		A.T. Stewart House		David Diller		
Subdivision:	J H Maltpress 1	Address:	Street:	Zip Code:			
	- or -	1501	Walnut St	75006			
Abstract:			Survey Area:	Carrollton Heights			
Tract:			Description:				
Survey:			One-story, square-plan brick house with inset "ell" porch on west and south elevations. Pyramidal roof. 1/1 wood sash windows. Primary entrance on south elevation. Wooden box columns support porch.				
Preservation Priority:	moderate						
Physical Condition:	fair						
Date Built:	1905						
Architect/Builder:							
Architectural Style:	Prairie Four-Square						
Wall Material:	wood siding						
Roof Material:	composition shingles						
Original Site:			Alterations:	Significance:			
Date Moved:			Several shed-roofed additions to east side.		Oldest known structure in neighborhood.		
Original Use:	residence						
Current Use:	residence						
Date Surveyed:

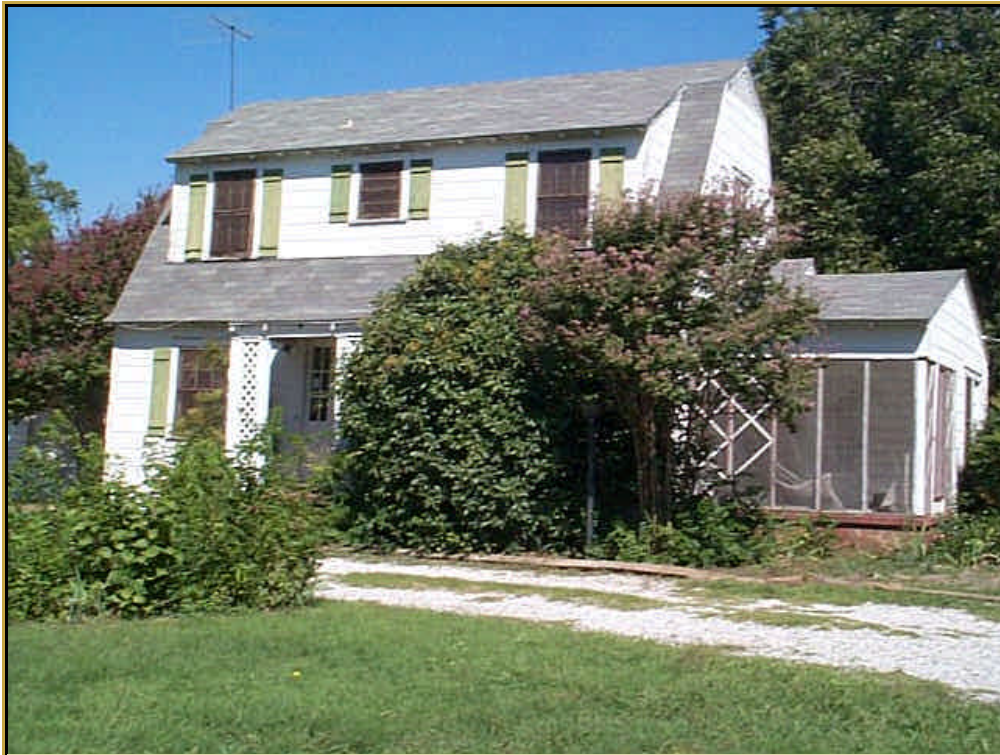
Lot:		Site Name:	McCormick House	Current Owner:	Alta Jean McCormick
Block:		Address:	1621	Street:	Walnut St
Subdivision:				Zip Code:	75006
	- or -				
Abstract:	798 p 505			Survey Area:	Carrollton Heights
Tract:		Description:			
Survey:	Joshua B Lee	<p>Rectangular plan side gable house with gambrel roof and continuous dormer across front. One and one-half story, with single story projection on east end mirroring main roof shape. Small covered entry porch.</p>			
Preservation Priority:	high				
Physical Condition:	good				
Date Built:	1925				
Architect/Builder:					
Architectural Style:	Dutch Colonial Revival				
Wall Material:	wood siding				
Roof Material:	composition shingles				
Original Site:		Alterations:		Significance:	Age; example of style. First owner, Leroy McCormick, was Carrollton's first pharmacist and a Mayor.
Date Moved:					
Original Use:	residence				
Current Use:	residence				
Date Surveyed:	12/18/01

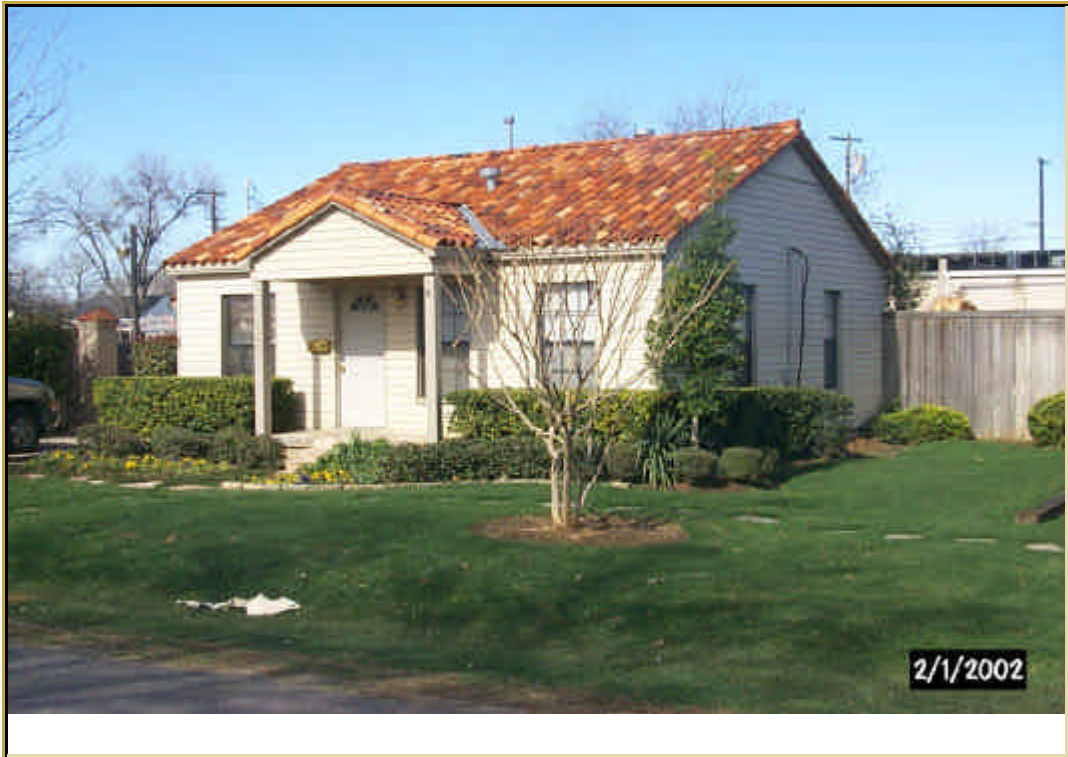
Lot:	10	Site Name:		Current Owner:	
Block:				Douglas K Straubmueller	
Subdivision:	D C Perry	Address:	Street:	Zip Code:	
	- or -	1207	Carroll Ave	75006	
Abstract:			Survey Area:	Francis Perry	
Tract:		Description:			
Survey:					
Preservation Priority:	moderate				
Physical Condition:	good				
Date Built:	1947				
Architect/Builder:					
Architectural Style:					
Wall Material:					
Roof Material:					
Original Site:		Alterations:	Roofing replaced with with tile.	Significance:	
Date Moved:					
Original Use:	residence				
Current Use:	office				
Date Surveyed:

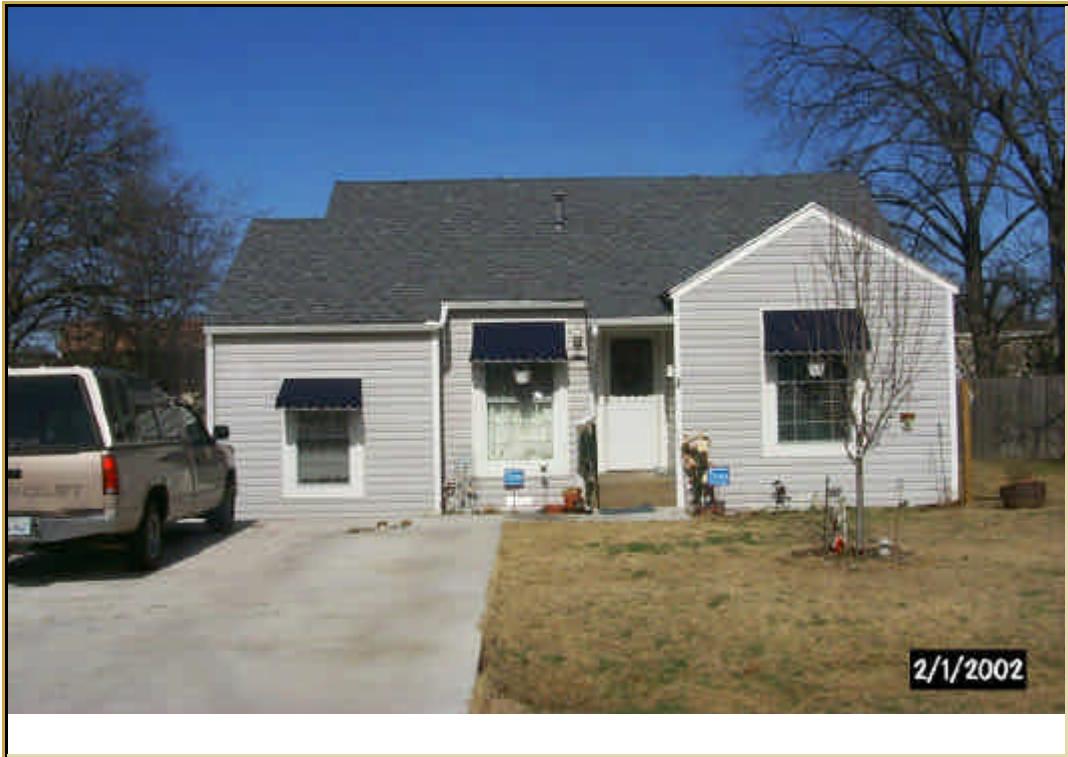
Lot:	9	Site Name:		Current Owner:	
Block:				Richard & Nancy Taft	
Subdivision:	J B Lesley	Address:	Street:	Zip Code:	
	- or -	1311	Carroll Ave	75006	
Abstract:				Survey Area:	Francis Perry
Tract:		Description:			
Survey:					
Preservation Priority:	moderate				
Physical Condition:	good				
Date Built:	1939				
Architect/Builder:					
Architectural Style:					
Wall Material:					
Roof Material:	composition shingles				
Original Site:		Alterations:		Significance:	
Date Moved:					
Original Use:	residence				
Current Use:	residence				
Date Surveyed:

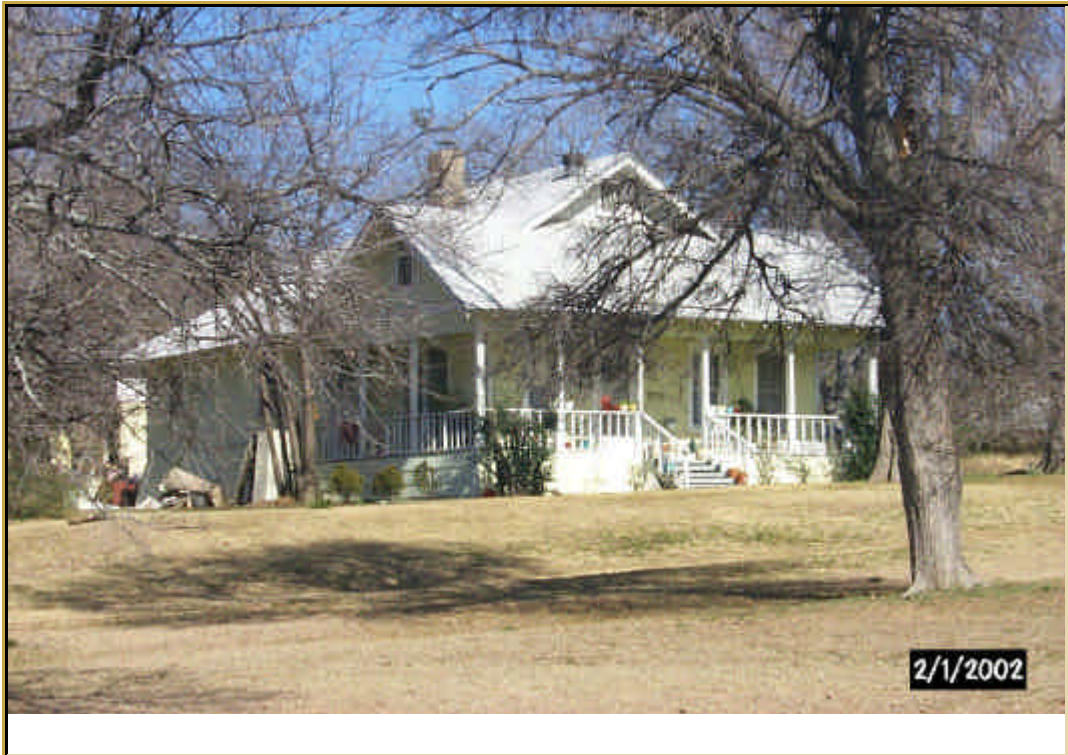
Lot:	<input type="text"/>	Site Name:	<input type="text"/>	Current Owner:	<input type="text"/>
Block:	<input type="text"/>			John Walvoord	
Subdivision:	<input type="text"/>	Address:	Street:	Zip Code:	
	- or -	1415	Crosby Rd E	75006	
Abstract:	799 p 250			Survey Area:	Francis Perry
Tract:	36	Description:			
Survey:	William Larner				
Preservation Priority:	moderate				
Physical Condition:	good				
Date Built:	1940				
Architect/Builder:	<input type="text"/>				
Architectural Style:	<input type="text"/>				
Wall Material:	<input type="text"/>				
Roof Material:	<input type="text"/>				
Original Site:	<input type="text"/>	Alterations:			
Date Moved:	<input type="text"/>	Significance:			
Original Use:	residence				
Current Use:	residence				
Date Surveyed:	<input type="text"/>

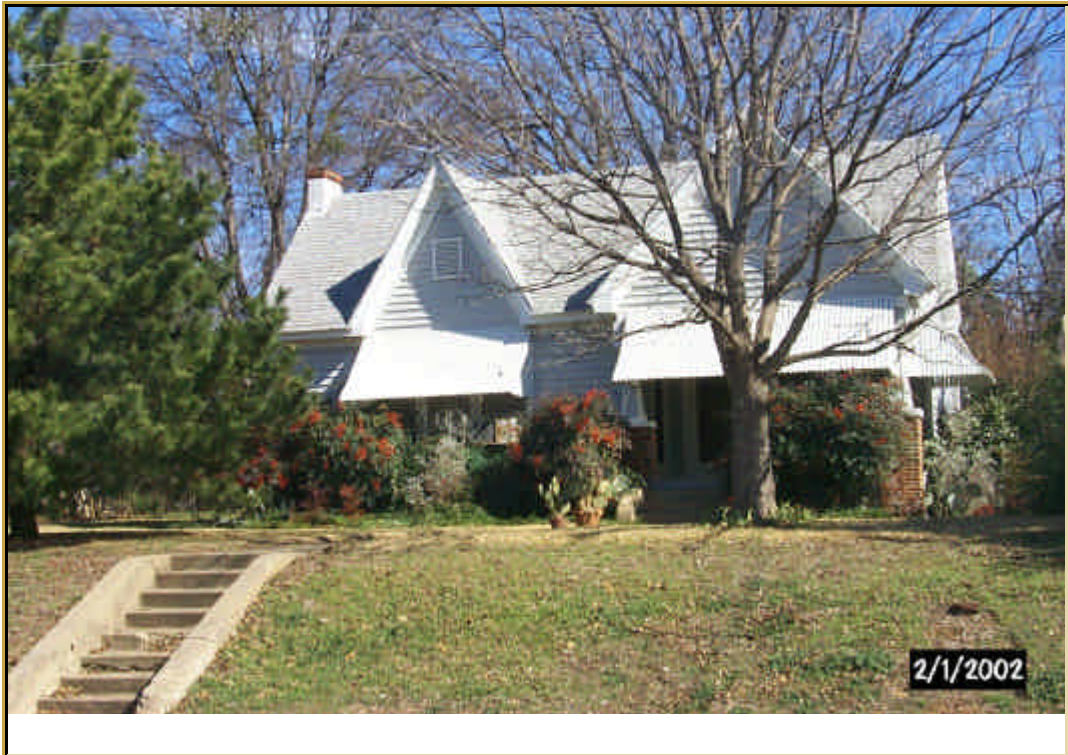
Lot:	5-12	Site Name:		Current Owner:	
Block:	4			Francis M & Lois F Good	
Subdivision:	New Carrollton	Address:	Street:	Zip Code:	
	- or -	1504	Denton Dr N	75006	
Abstract:				Survey Area:	Duncan Heights
Tract:		Description:			
Survey:					
Preservation Priority:					
Physical Condition:					
Date Built:	1935				
Architect/Builder:					
Architectural Style:					
Wall Material:					
Roof Material:					
Original Site:		Alterations:		Significance:	
Date Moved:					
Original Use:	residence				
Current Use:	residence				
Date Surveyed:

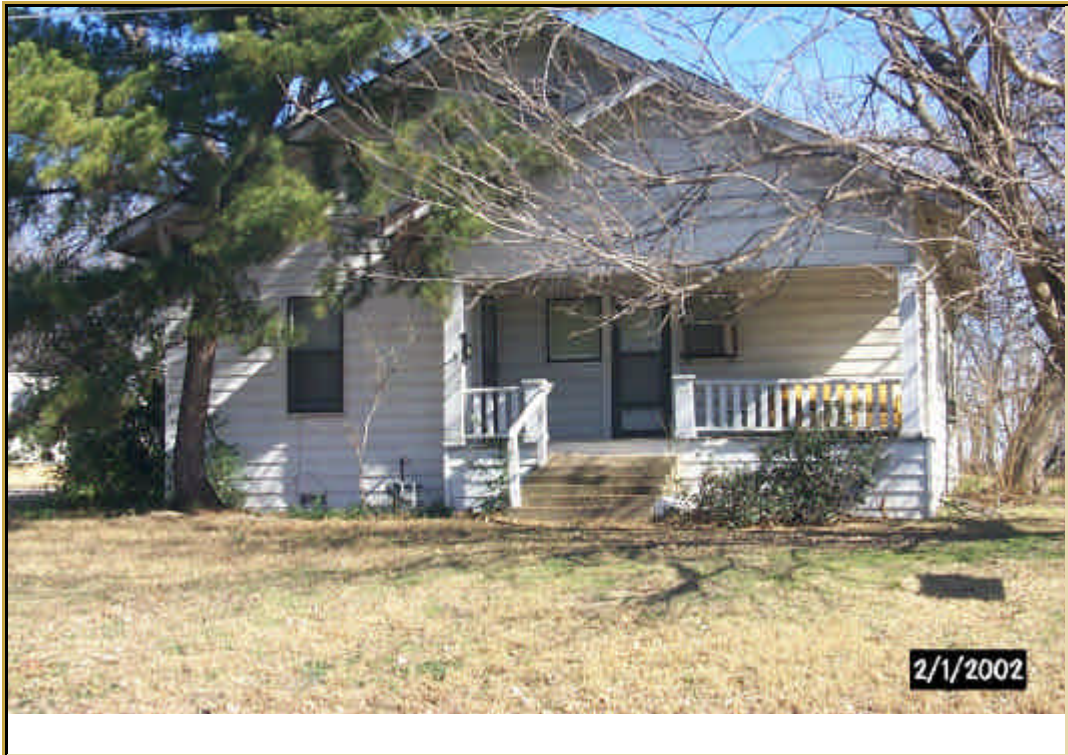
Lot:	<input type="text"/>	Site Name:	<input type="text"/>	Current Owner:	<input type="text"/>
Block:	<input type="text"/>			Gary R Gravley	
Subdivision:	<input type="text"/>	Address:	Street:	Zip Code:	
	- or -	1510	Denton Dr N	75006	
Abstract:	798 p 125			Survey Area:	A.W. Perry (North)
Tract:	1	Description:			
Survey:	Joshua B Lee				
Preservation Priority:	<input type="text"/>				
Physical Condition:	<input type="text"/>				
Date Built:	1917				
Architect/Builder:	<input type="text"/>				
Architectural Style:	<input type="text"/>				
Wall Material:	<input type="text"/>				
Roof Material:	<input type="text"/>				
Original Site:	<input type="text"/>	Alterations:	Significance:		
Date Moved:	<input type="text"/>				
Original Use:	residence				
Current Use:	residence				
Date Surveyed:	<input type="text"/>

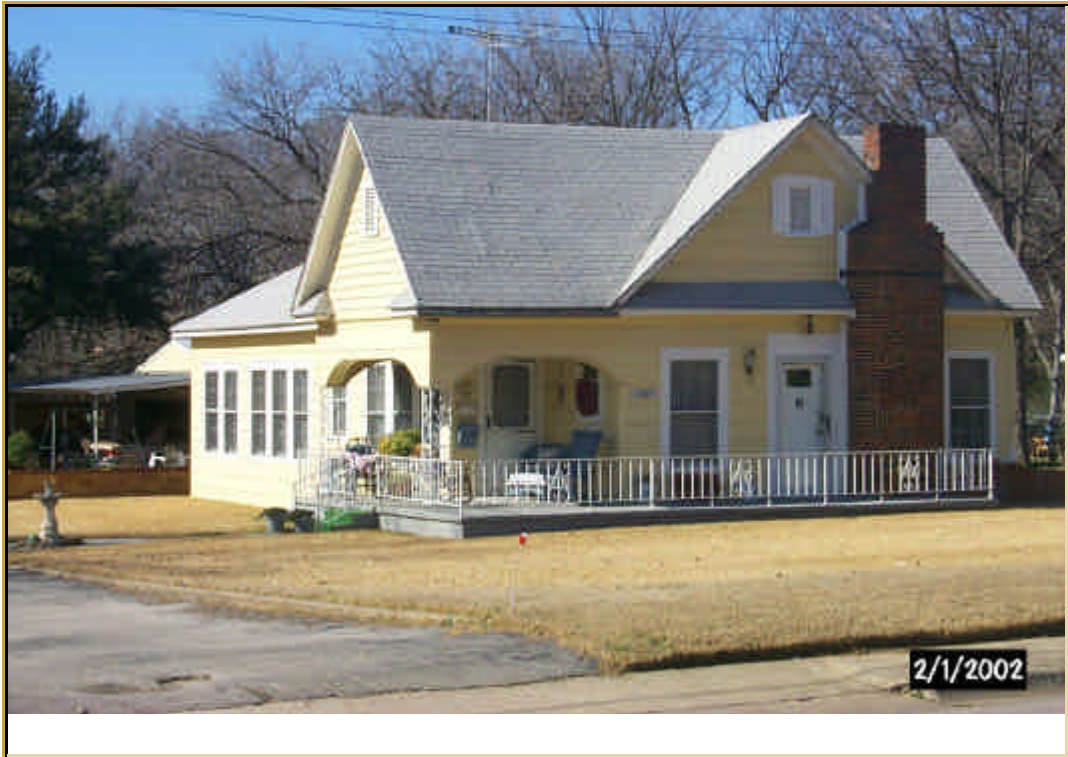
Lot:	<input type="text"/>	Site Name:	<input type="text"/>	Current Owner:	<input type="text"/>
Block:	<input type="text"/>	<input type="text"/>		Norman & Georgeanna Black Trust	
Subdivision:	<input type="text"/>	Address:	Street:	Zip Code:

- or -	1607	Denton Dr N	<input type="text"/>	
Abstract:	519 p 255	Survey Area:		Duncan Heights	
Tract:	<input type="text"/>	Description:			
Survey:	Martha P Green	<div style="border: 1px solid black; height: 150px; width: 100%;"></div>			
Preservation Priority:	<input type="text"/>				
Physical Condition:	<input type="text"/>				
Date Built:	1926				
Architect/Builder:	<input type="text"/>				
Architectural Style:	<input type="text"/>				
Wall Material:	<input type="text"/>	Alterations:		Significance:	
Roof Material:	<input type="text"/>	<div style="border: 1px solid black; height: 60px; width: 100%;"></div>		<div style="border: 1px solid black; height: 60px; width: 100%;"></div>	
Original Site:	<input type="text"/>				
Date Moved:	<input type="text"/>				
Original Use:	residential				
Current Use:	residential				
Date Surveyed:	<input type="text"/>

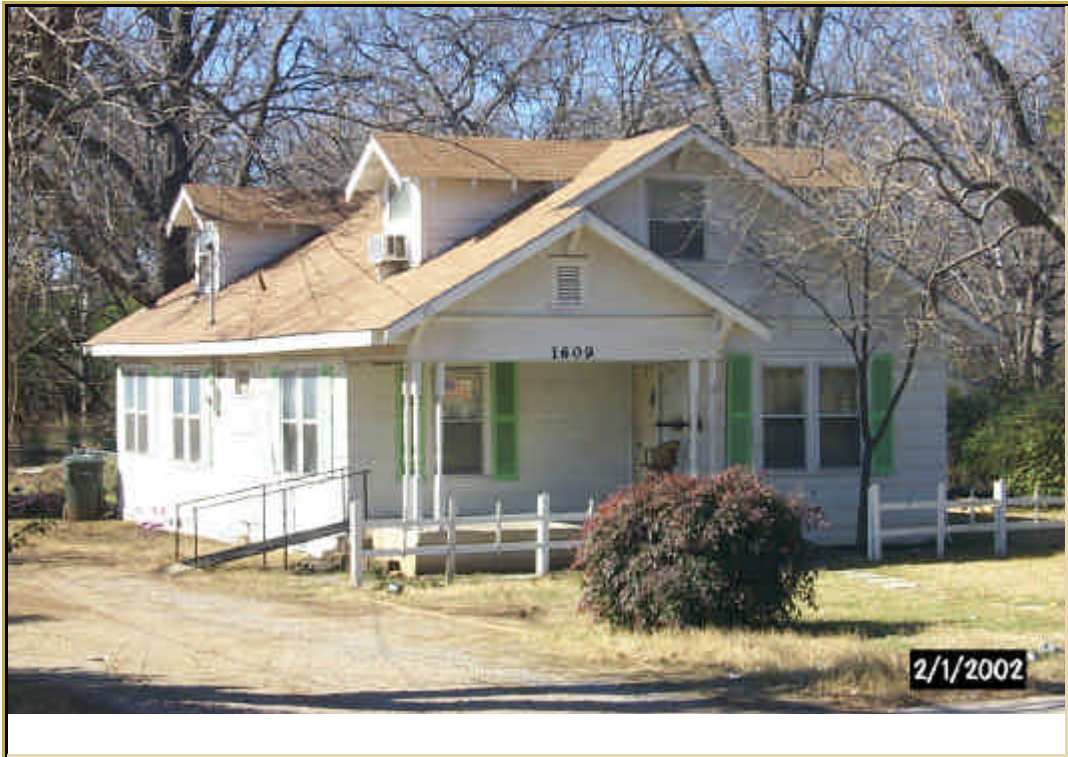
Lot:	<input type="text"/>	Site Name:	<input type="text"/>	Current Owner:	<input type="text"/>
Block:	<input type="text"/>		<input type="text"/>	Roque Flores	
Subdivision:	<input type="text"/>	Address:	Street:	Zip Code:	
	- or -	1609	Denton Dr N	75006	
Abstract:	519 p 255			Survey Area:	Duncan Heights
Tract:	18	Description:			
Survey:	Martha P Green				
Preservation Priority:	<input type="text"/>				
Physical Condition:	<input type="text"/>				
Date Built:	1948				
Architect/Builder:	<input type="text"/>				
Architectural Style:	<input type="text"/>				
Wall Material:	<input type="text"/>				
Roof Material:	<input type="text"/>				
Original Site:	<input type="text"/>	Alterations:	Significance:		
Date Moved:	<input type="text"/>				
Original Use:	residential				
Current Use:	residential				
Date Surveyed:	<input type="text"/>

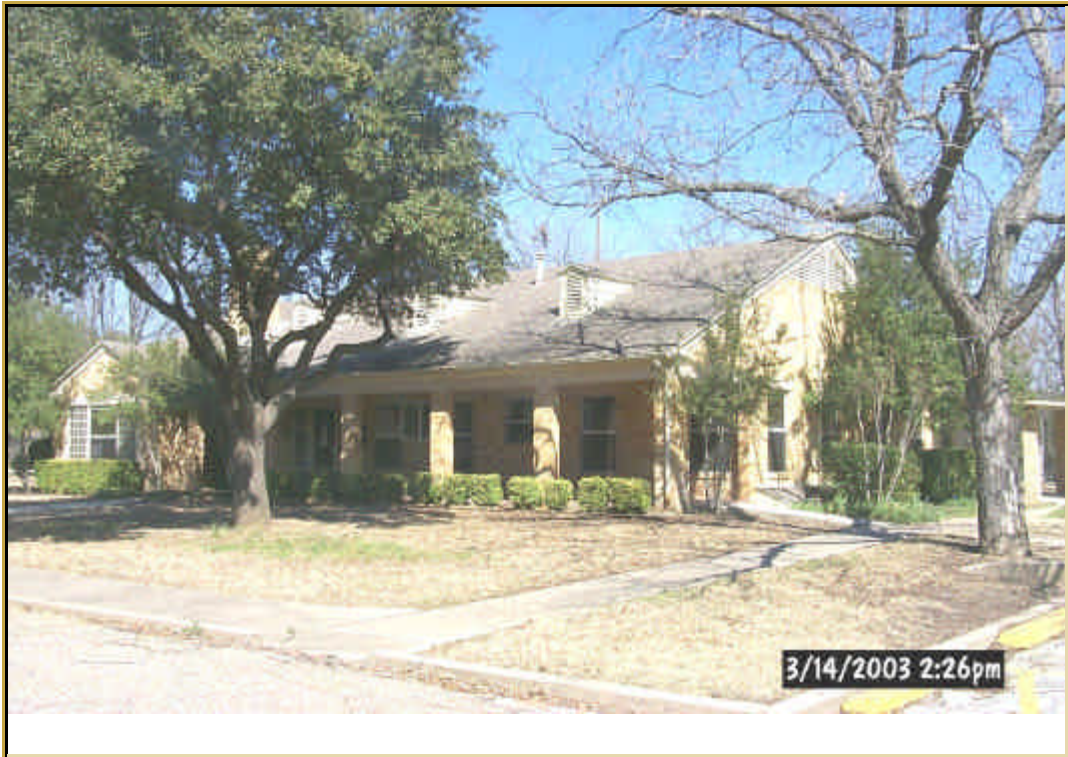
Lot:	1	Site Name:	Thomas Center	Current Owner:	City of Carrollton
Block:	1	Address:	1620	Street:	Denton Dr N
Subdivision:	Thomas Park	Zip Code:	75006		
	- or -				
Abstract:		Survey Area:	A.W. Perry (North)		
Tract:		Description:	<p>Ranch-style brick house. Asymmetrical floor plan. Carved stone or cast concrete lintels over doors and windows, and quoin-like details around exterior windows. Covered porch across much of the front, supported by brick pillars. Dormers on room have vents, not windows. Some glass-block windows.</p>		
Survey:					
Preservation Priority:					
Physical Condition:	Good				
Date Built:	1945				
Architect/Builder:					
Architectural Style:					
Wall Material:	Brick				
Roof Material:	Asphalt Shingles				
Alterations:		Significance:			
Original Site:					
Date Moved:					
Original Use:					
Current Use:					
Date Surveyed:

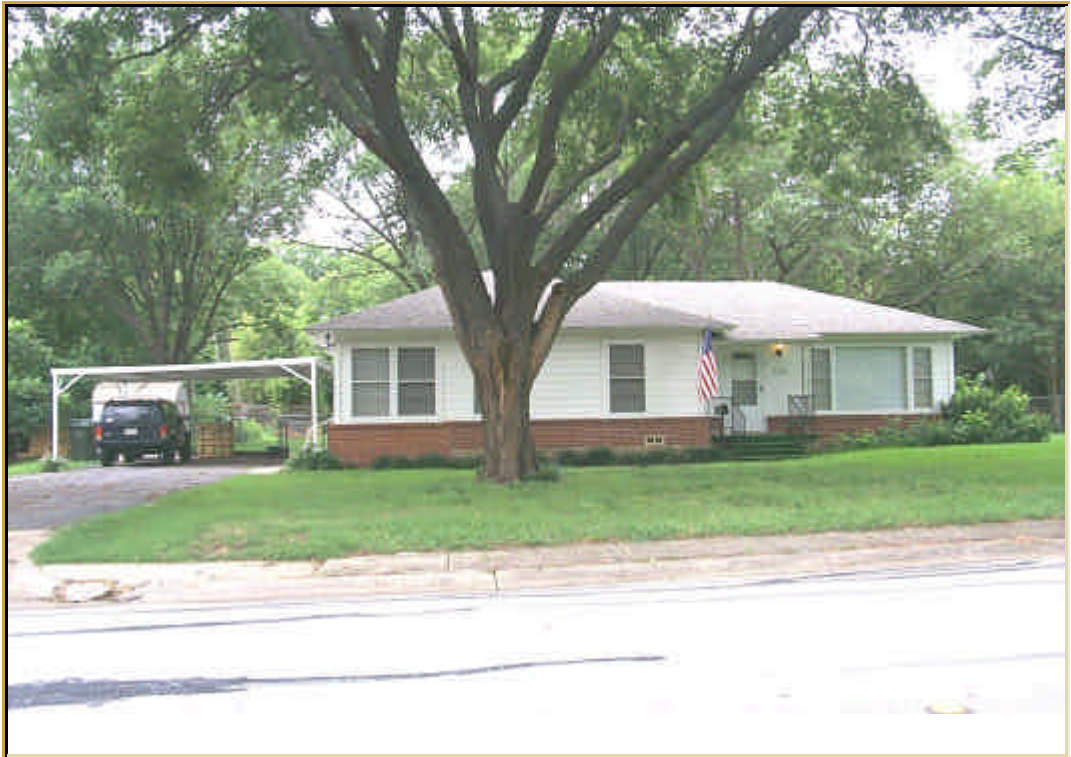
- or -	1711	Denton Dr N	75006	
Abstract:	519 p 255			Survey Area:	Duncan Heights
Tract:	<input type="text"/>	Description:			
Survey:	Martha P Green	Single story Ell plan with add-on extensions. Off-center porch.			
Preservation Priority:	<input type="text"/>				
Physical Condition:	Good				
Date Built:	1951				
Architect/Builder:	<input type="text"/>				
Architectural Style:	<input type="text"/>				
Wall Material:	Brick & Wood Siding				
Roof Material:	Asphalt Shingles				
Original Site:	<input type="text"/>	Alterations:	Significance:		
Date Moved:	<input type="text"/>				
Original Use:	<input type="text"/>				
Current Use:	<input type="text"/>				
Date Surveyed:	<input type="text"/>

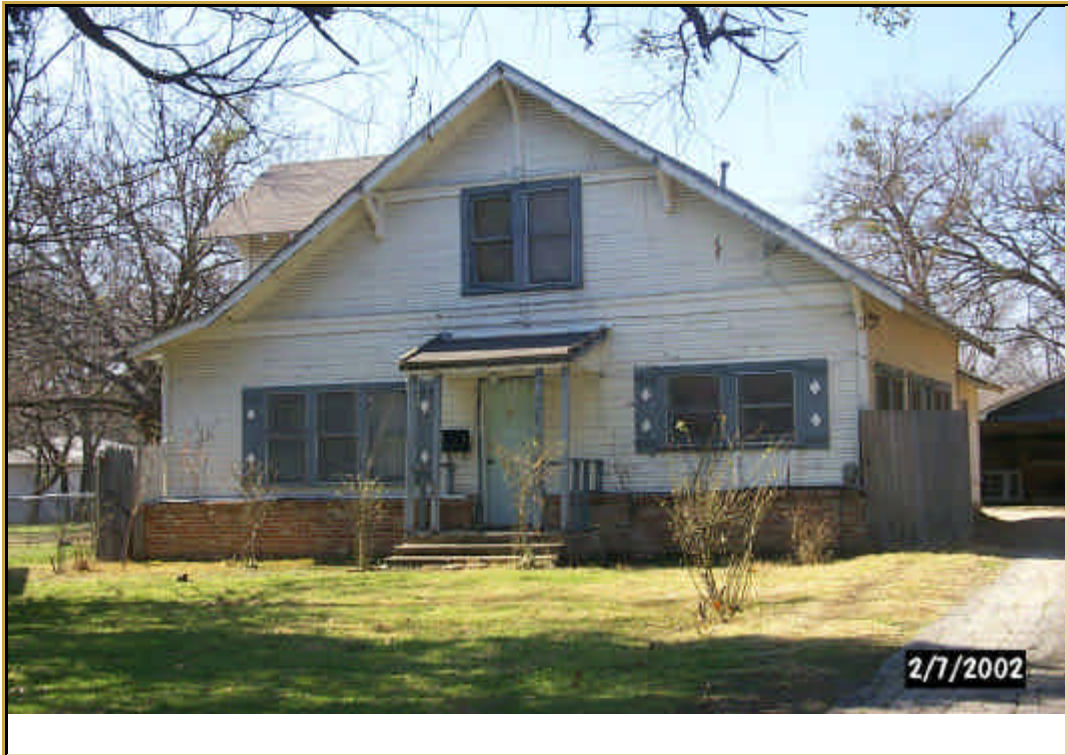
Lot:	3	Site Name:		Current Owner:	
Block:				Ingle Interests Inc/Benito Martinez	
Subdivision:	Terraceview	Address:	Street:	Zip Code:	
	- or -	1819	Denton Dr N	75006	
Abstract:			Survey Area:	Duncan Heights	
Tract:		Description:			
Survey:		Front and side gabled plan with shed roof covering the entrance.			
Preservation Priority:					
Physical Condition:					
Date Built:	1919				
Architect/Builder:					
Architectural Style:					
Wall Material:					
Roof Material:					
		Alterations:	Significance:		
Original Site:					
Date Moved:					
Original Use:	residence				
Current Use:	residence				
Date Surveyed:

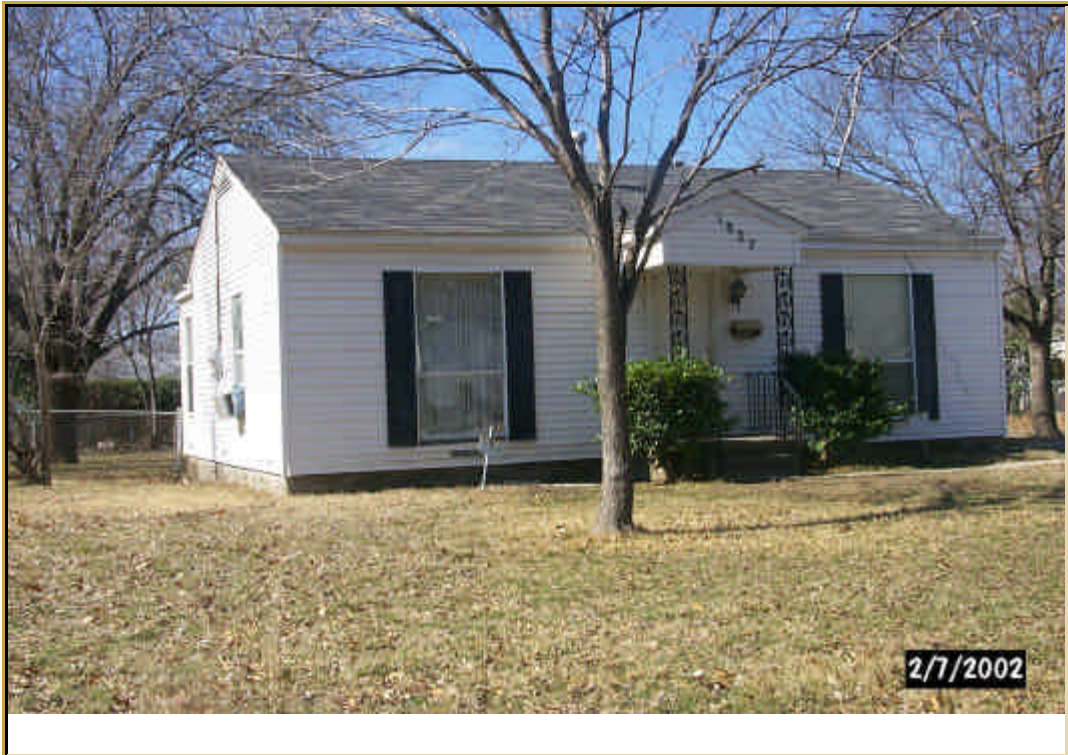
Lot:	8	Site Name:		Current Owner:	
Block:	4			Ingle Real Estate	
Subdivision:	Whitlock	Address:	Street:	Zip Code:	
	- or -	1827	Denton Dr N	75006	
Abstract:				Survey Area:	Duncan Heights
Tract:		Description:			
Survey:		Rectangular-plan. Simple gabled roof. Small front porch with gable roof facing street supported by two cast-metal supports. Typical middle-class post-World-War-II residence.			
Preservation Priority:					
Physical Condition:	Good				
Date Built:	1949				
Architect/Builder:					
Architectural Style:					
Wall Material:	Wood Siding				
Roof Material:	Asphalt Shingles				
Original Site:		Alterations:	Significance:		
Date Moved:					
Original Use:	residential				
Current Use:	residential				
Date Surveyed:

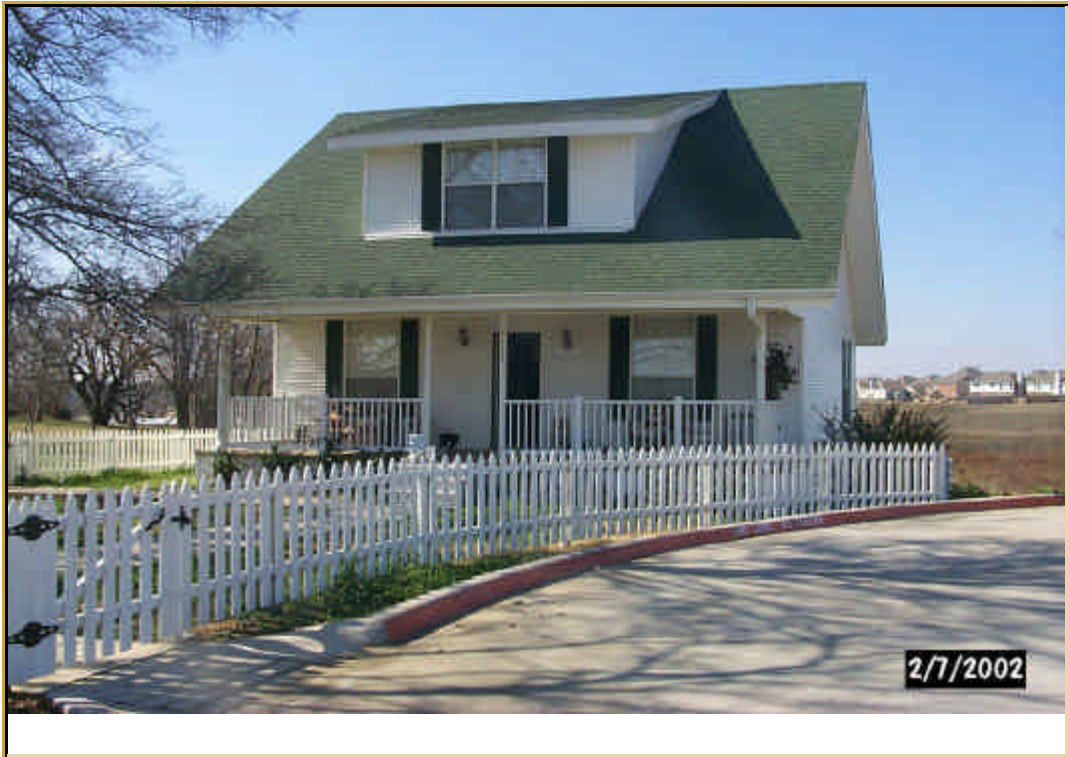
Lot:	<input type="text"/>	Site Name:	<input type="text"/>	Current Owner:	<input type="text"/>			
Block:	<input type="text"/>	<input type="text"/>	Josey Homestead	<input type="text"/>	Cityof Carrollton			
Subdivision:	<input type="text"/>	Address:	<input type="text"/>	Street:	<input type="text"/>

- or -	<input type="text"/>	2121	<input type="text"/>	Josey Ln N			
				<input type="text"/>	75006			
Abstract:	<input type="text"/>			Survey Area:	<input type="text"/>			
Tract:	<input type="text"/>				Josey Rancho			
Survey:	<input type="text"/>	Description:	<div style="border: 1px solid black; padding: 5px;"> <p>White house w/ green roof.</p> </div>					
Preservation Priority:	<input type="text"/>							
Physical Condition:	<input type="text"/>	good						
Date Built:	<input type="text"/>	1939 (?)						
Architect/Builder:	<input type="text"/>							
Architectural Style:	<input type="text"/>							
Wall Material:	<input type="text"/>							
Roof Material:	<input type="text"/>							
Original Site:	<input type="text"/>	Alterations:				<input type="text"/>	Significance:	<input type="text"/>
Date Moved:	<input type="text"/>							
Original Use:	<input type="text"/>							
Current Use:	<input type="text"/>

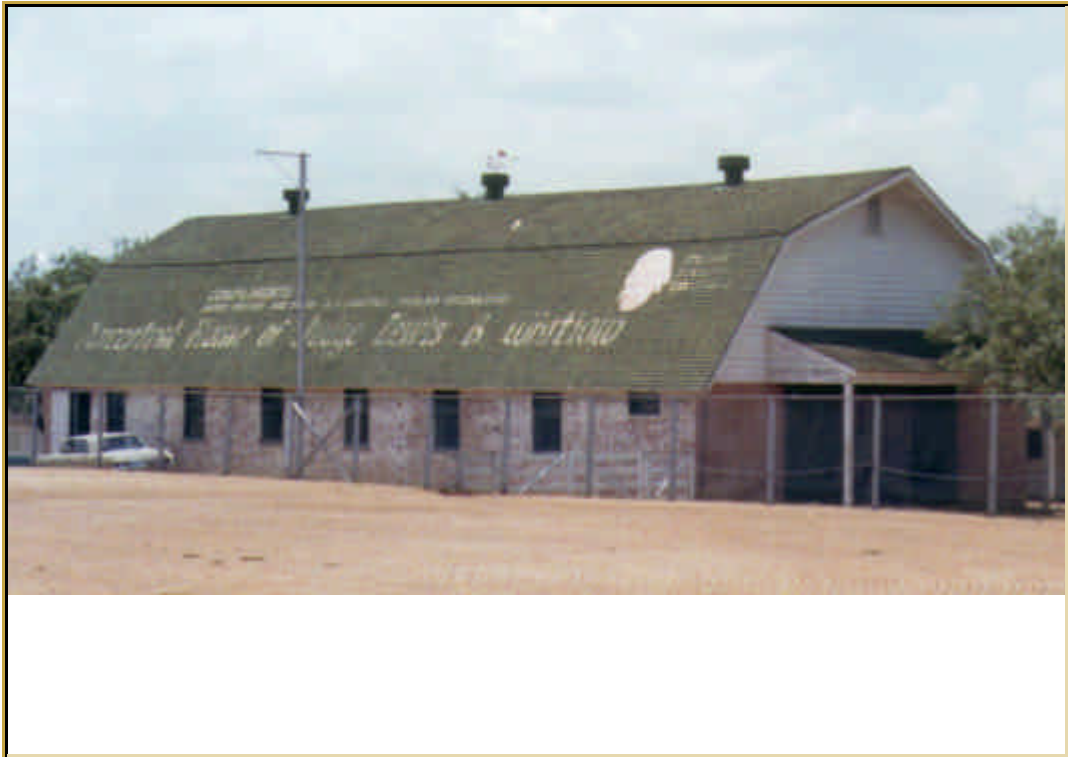
Lot:	<input type="text"/>	Site Name:	<input type="text" value="Josey Rancho Barn"/>	Current Owner:	<input type="text" value="Josey Rancho Barn, LP"/>
Block:	<input type="text"/>	Address:	<input type="text" value="2125"/>	Street:	<input type="text" value="Josey Ln N"/>
Subdivision:	<input type="text" value="- or -"/>			Zip Code:	<input type="text" value="75006"/>
Abstract:	<input type="text"/>			Survey Area:	<input type="text" value="Josey Rancho"/>
Tract:	<input type="text"/>	Description:			
Survey:	<input type="text"/>	<p>Josey Rancho Barn.</p>			
Preservation Priority:	<input type="text"/>				
Physical Condition:	<input type="text" value="good"/>				
Date Built:	<input type="text" value="1925 (?)"/>				
Architect/Builder:	<input type="text"/>				
Architectural Style:	<input type="text"/>				
Wall Material:	<input type="text"/>	Alterations:	<input type="text" value="Extensive remodeling/rehabilitation into an office building."/>	Significance:	<input type="text"/>

Roof Material:	<input type="text"/>	Original Site:	<input type="text"/>		
		Date Moved:	<input type="text"/>		
		Original Use:	<input type="text" value="barn"/>		
		Current Use:	<input type="text" value="office"/>		
Date Surveyed:	<input type="text"/>

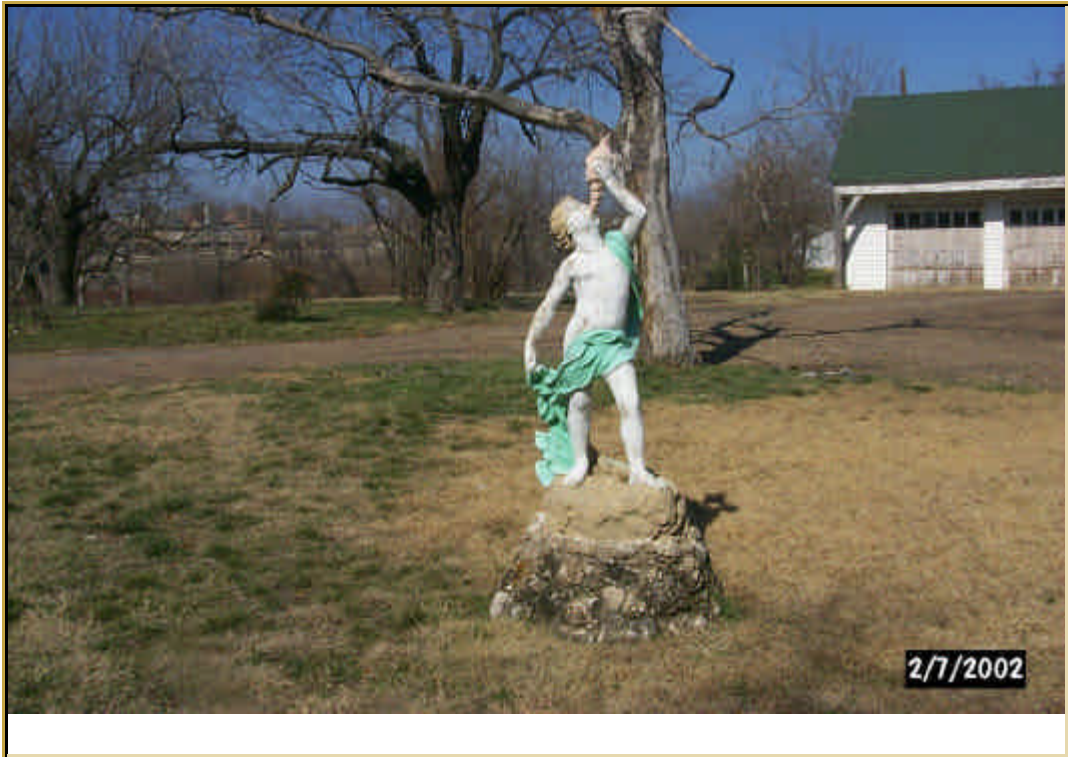
Lot:	<input type="text"/>	Site Name:	<input type="text" value="Josey Rancho Statue"/>	Current Owner:	<input type="text"/>
Block:	<input type="text"/>	Address:	<input type="text" value="2005"/>	Street:	<input type="text" value="Josey Ln N"/>
Subdivision:	<input type="text" value="- or -"/>			Zip Code:	<input type="text" value="75006"/>
Abstract:	<input type="text"/>			Survey Area:	<input type="text"/>
Tract:	<input type="text"/>	Description:			
Survey:	<input type="text"/>	Statue of boy.			
Preservation Priority:	<input type="text"/>				
Physical Condition:	<input type="text"/>				
Date Built:	<input type="text"/>				
Architect/Builder:	<input type="text"/>				
Architectural Style:	<input type="text"/>				
Wall Material:	<input type="text"/>				
Roof Material:	<input type="text"/>				
Original Site:	<input type="text"/>	Alterations:	<input type="text"/>	Significance:	<input type="text"/>
Date Moved:	<input type="text"/>
